High Speed Rail (Crewe to Manchester)

BID HE-004-0MA05

MA05: Risley to Bamfurlong

Historic environment field survey report

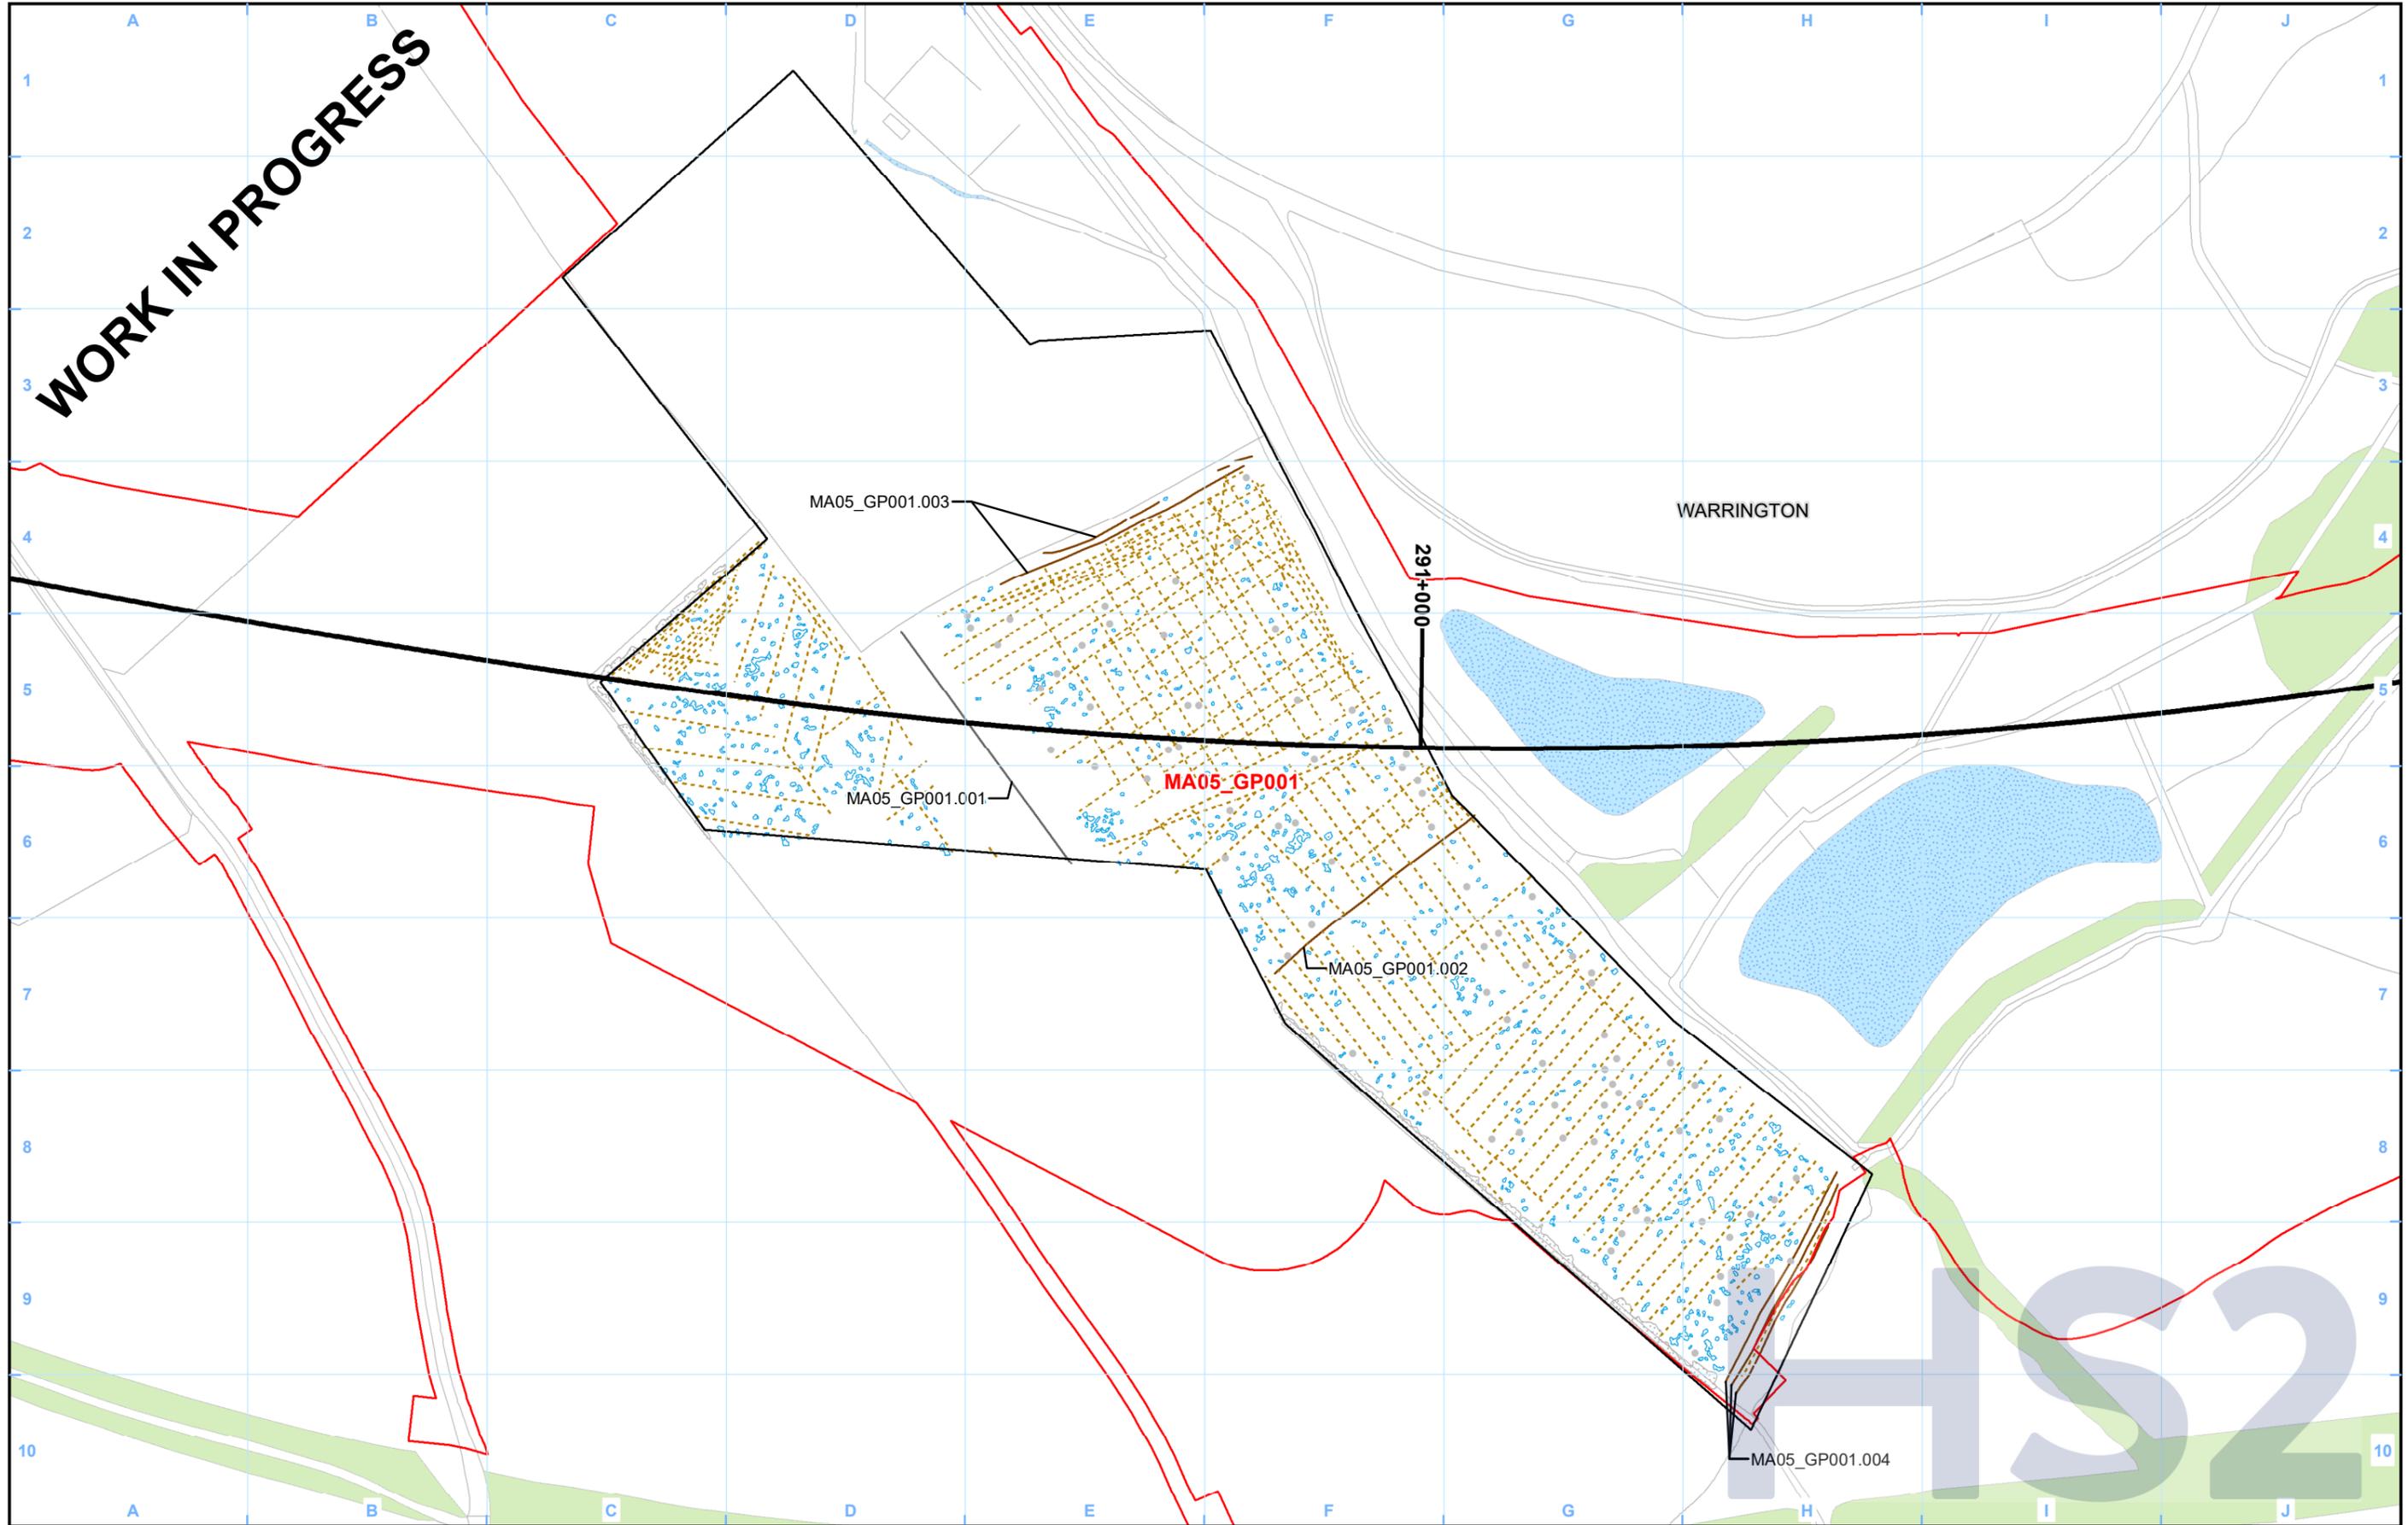
Map Number	HE-004_MA05_Figure4
Map Name	Site MA05_GP001 Interpretation
	Community Area MA05: Risley to Bamfurlong

- 3.2.9 Ferrous anomalies, characterised as individual 'spikes', were identified across the survey area. The spikes are typically caused by ferrous (magnetic) material, either on the ground surface or in the plough-soil.

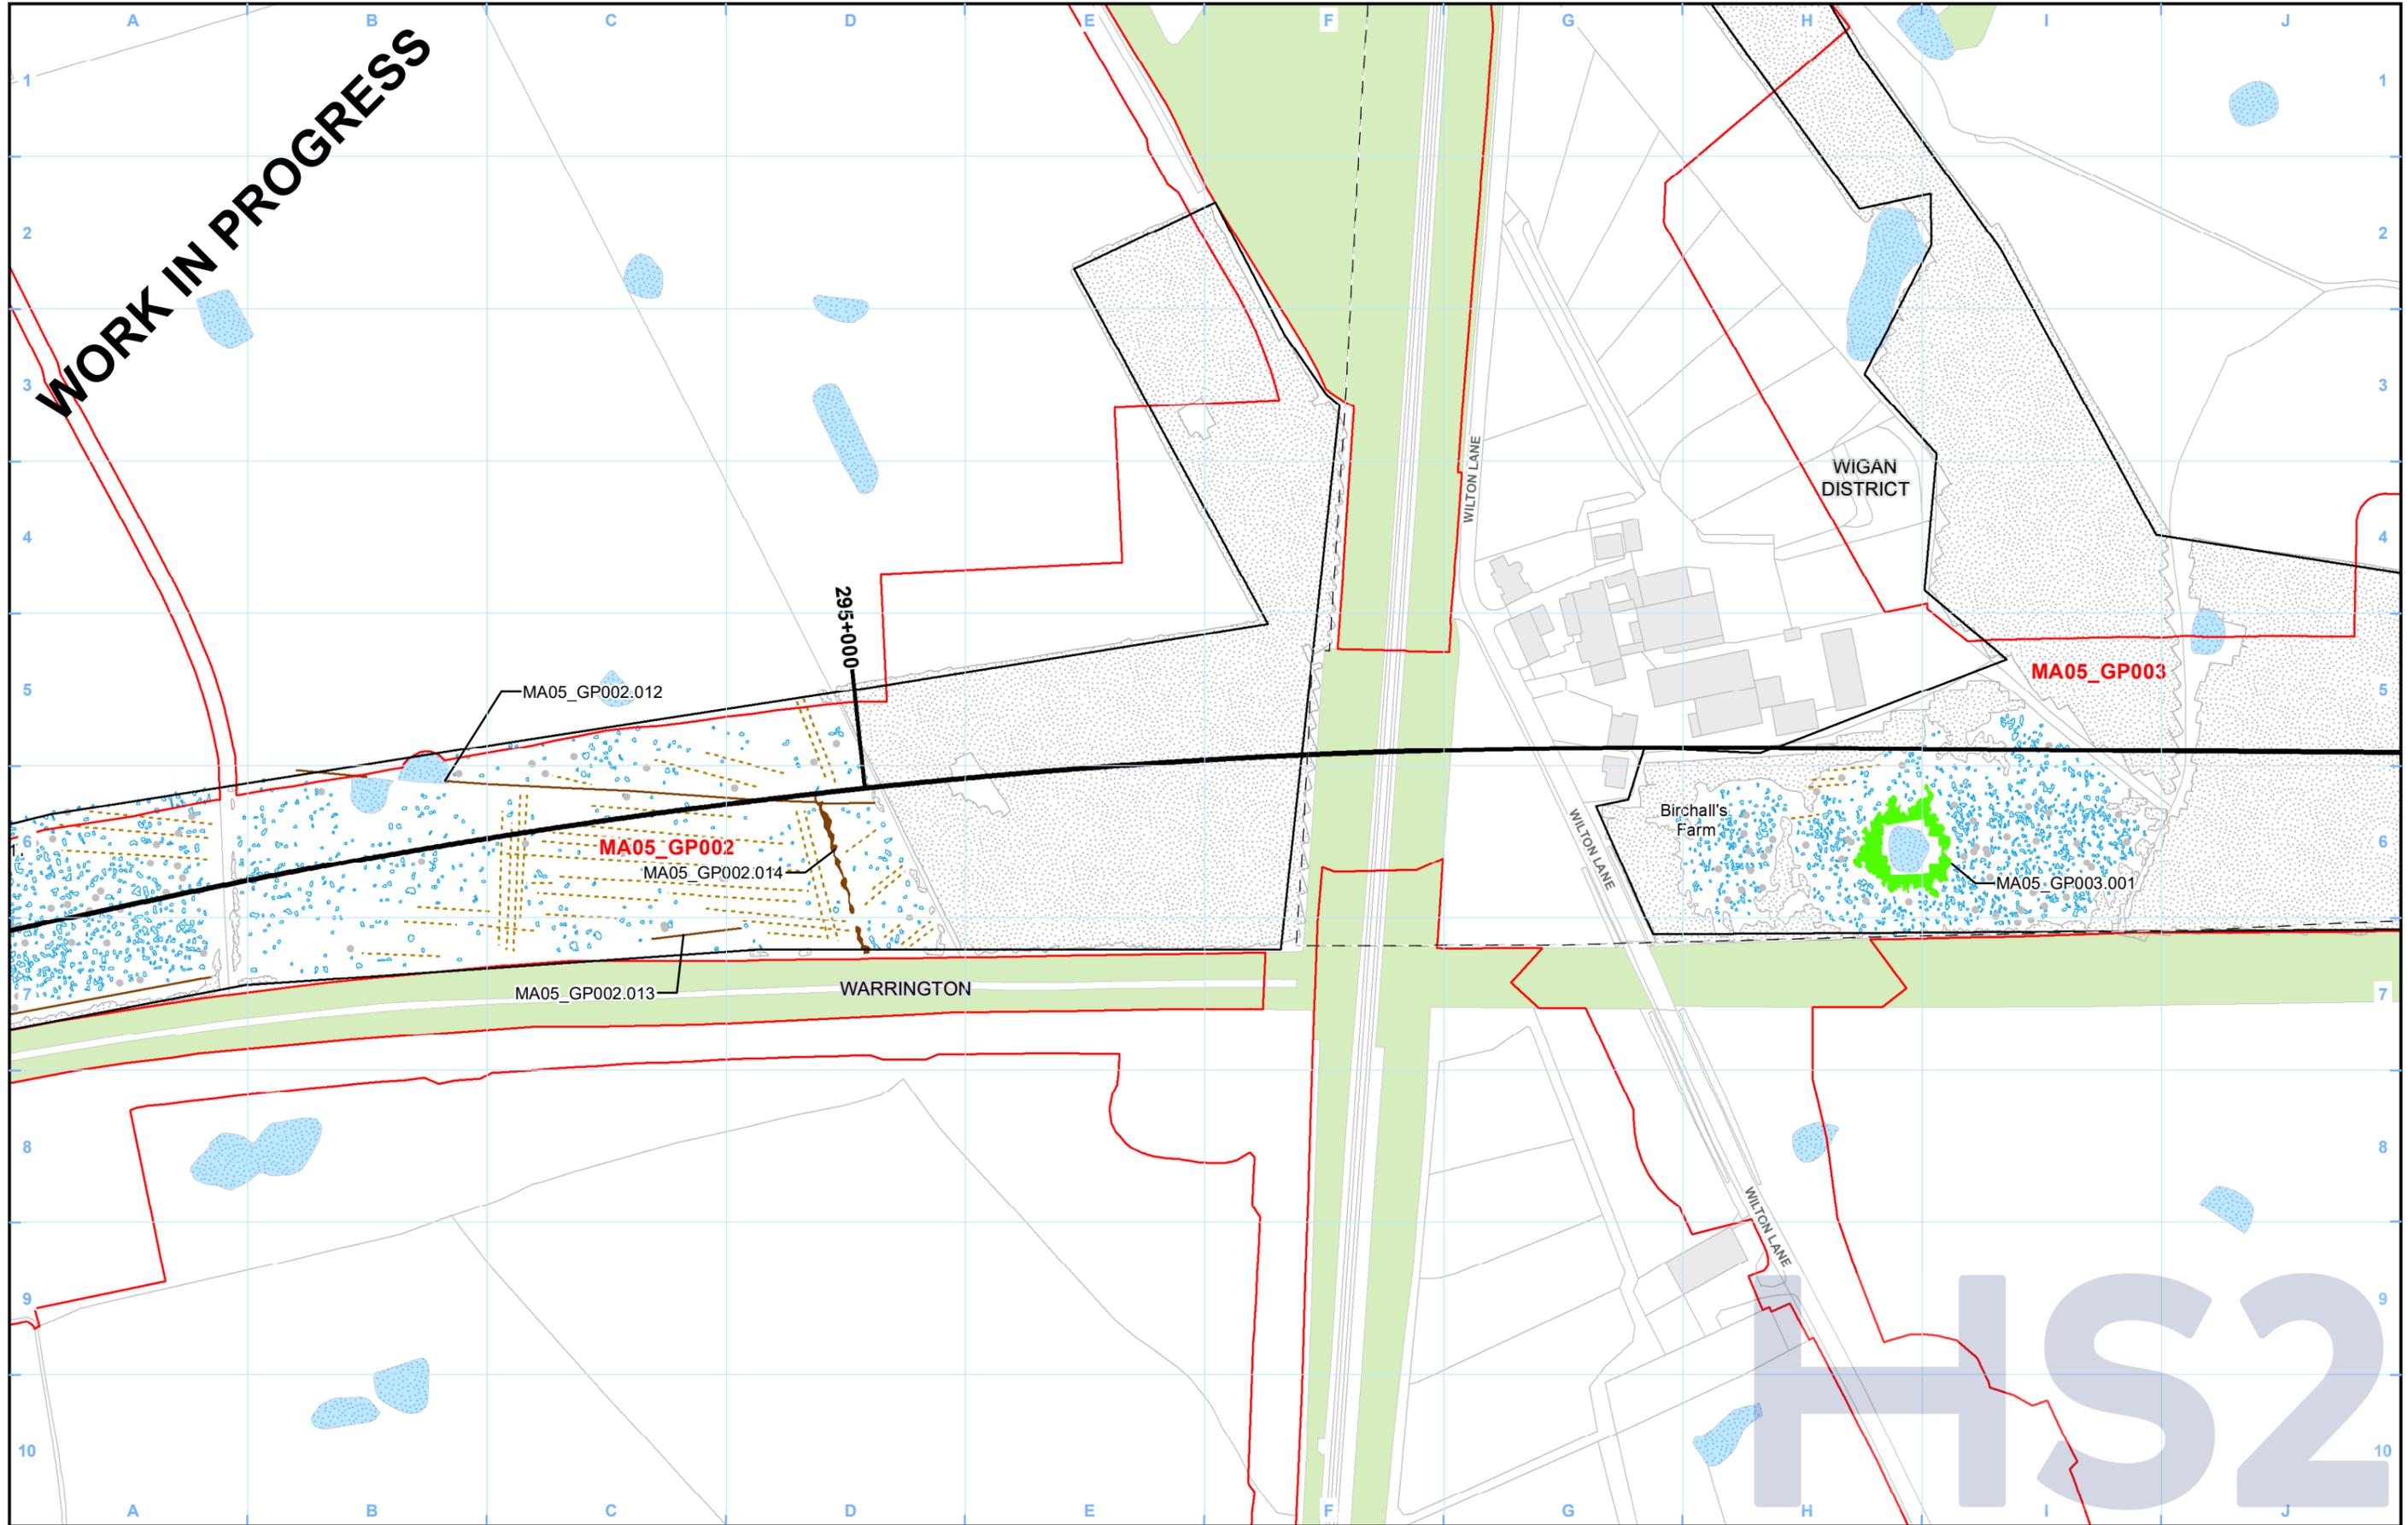
Map Number HE-004_MA05_Figure13

- 3.4.2 An area of high magnetic disturbance located in the centre of the south-eastern field corresponds with a former marl pit¹⁵ (see Figures 13 and 16, anomaly MA05_GP003.001) depicted on the 1849 Ordnance Survey map¹³ later used as a pond. The disturbance was caused by the magnetic properties (brick, tile, iron etc.) of the material used to infill the former pond.

Reference	Asset UID	Anomaly category	Feature type	Period	Comment	Figure	NGR
MA05_GP003.001		Extraction	Marl pit	Post-medieval	Highly magnetic material within a former pond, shown on 1849 Ordnance Survey map. Former marl pit.	Figures 12, 13, 15 and 16	363528 396449
MA05_GP004.001		Extraction	Quarry	Post-medieval	Quarry, later, used as a pond, as shown on the 1849 Ordnance Survey map. Disturbance likely caused by magnetic objects within backfill.	Figures 18 and 19	363071 397009
MA05_GP004.002		Extraction	Marl pit	Post-medieval	Highly magnetic material within a former pond, shown on 1849 Ordnance Survey map. Former marl pit.	Figures 18 and 19	363286 397068
MA05_GP004.003		Agricultural historic	Field boundary	Post-medieval	A former field boundary depicted on the on 1849 Ordnance Survey map.	Figures 18 and 19	362971 397009
MA05_GP004.004		Agricultural historic	Field boundary	Post-medieval	A former field boundary depicted on the on 1849 Ordnance Survey map.	Figures 18 and 19	363217 397037

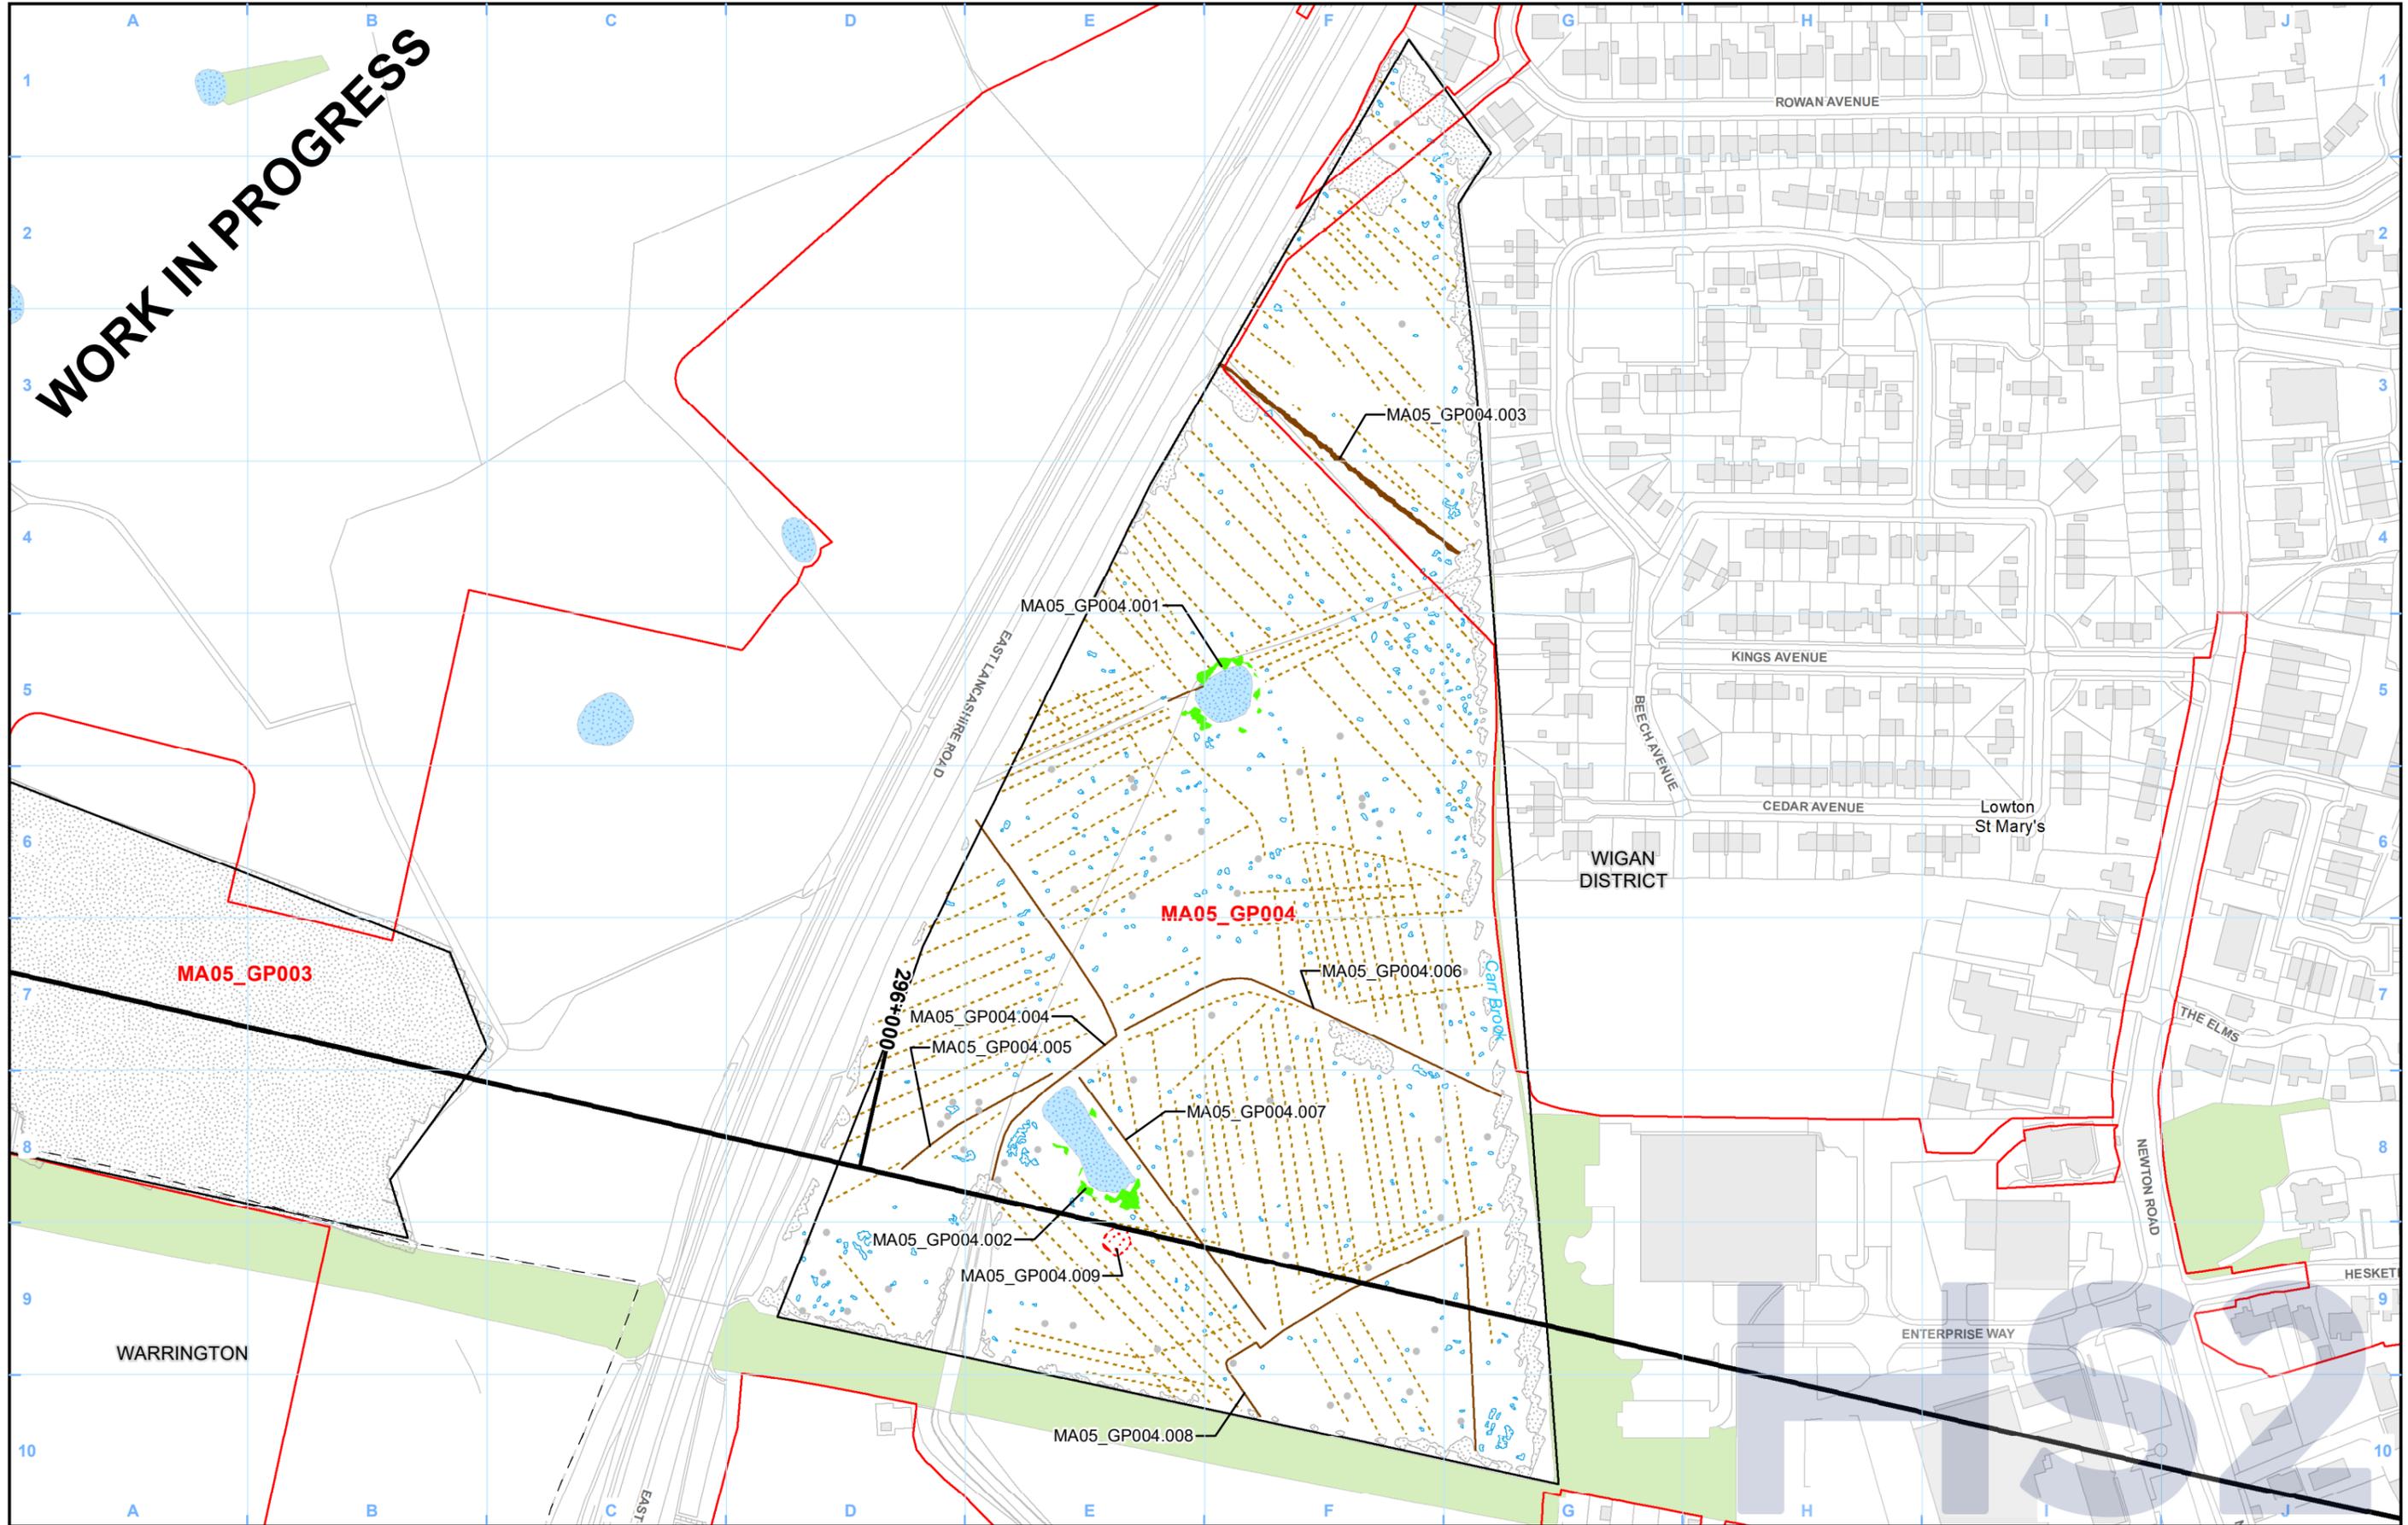
Map Number HE-004_MA05_Figure19
 Map Name Site MA05_GP004 Interpretation
 Community Area MA05: Risley to Bamfurlong

- 3.5.3 Two areas of high magnetic disturbance located in the centre and east of the field correspond with former marl pits¹⁶ (see Figure 19, anomalies MA05_GP004.001 and MA05_GP004.002) depicted on the 1849 Ordnance Survey map¹³ later used as ponds. The disturbance was caused by the magnetic properties (brick, tile, iron etc.) of the material used to infill the former ponds.

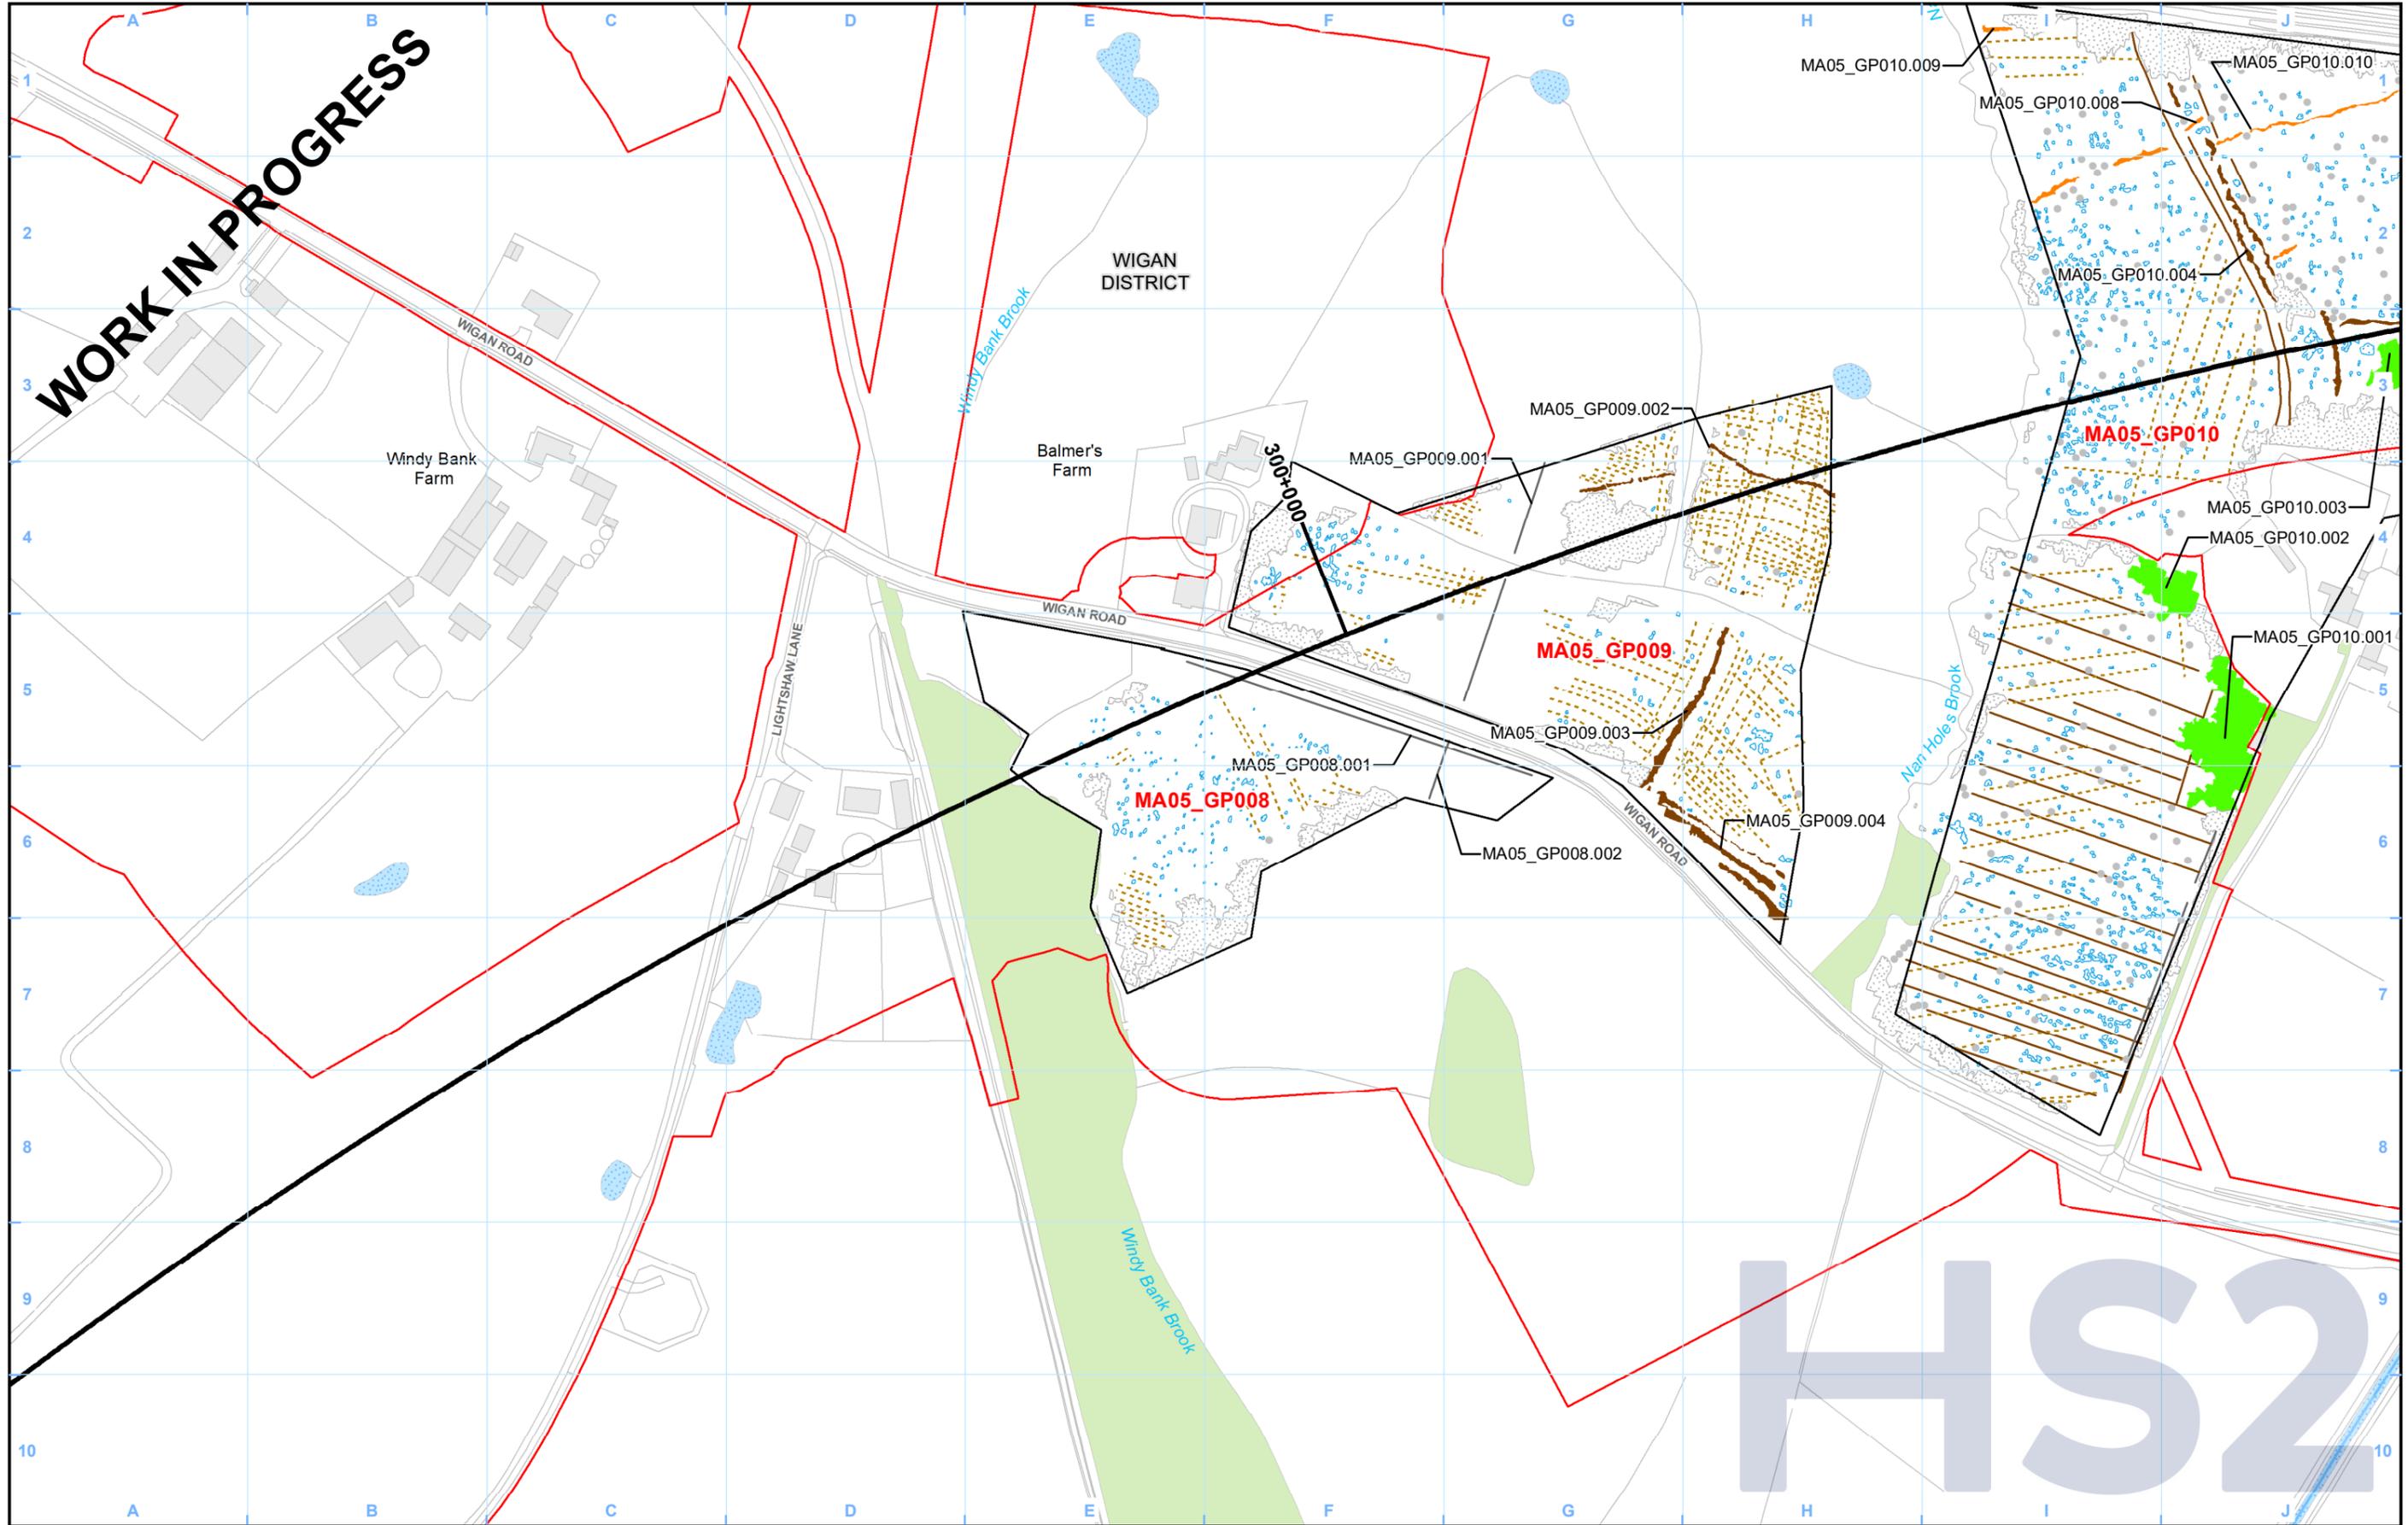
Map Number HE-004_MA05_Figure25
 Map Name Site MA05_GP008/MA05_GP009 Interpretation
 Community Area MA05: Risley to Bamfurlong

- 3.7.6 The disturbance caused by two high magnitude linear anomalies, indicative of service pipes (detailed below), masks the location of the now demolished properties of Holt's Well Brow.
- 3.7.7 Magnetic disturbance around the field edges was due to ferrous material within, or adjacent to the boundaries.

MA05_GP009.003		Agricultural historic	Field boundary	Post-medieval	A former field boundary depicted on the on 1849 Ordnance Survey map.	Figures 24, 25, 27 and 28	360714 399979
MA05_GP009.004		Agricultural historic	Field boundary	Post-medieval	A former field boundary depicted on the on 1849 Ordnance Survey map.	Figures 24, 25, 27 and 28	360761 400011
MA05_GP010.001		Extraction	Quarry	Post-medieval	Quarry, later used as a pond, as shown on the 1849 Ordnance Survey map. Disturbance likely caused by magnetic objects within backfill.	Figures 24, 25, 27 and 28	360647 400192
MA05_GP010.002		Extraction	Quarry	Post-medieval	Quarry, later used as a pond, as shown on the 1849 Ordnance Survey map. Disturbance likely caused by magnetic objects within backfill.	Figures 24, 25, 27 and 28	360597 400149
MA05_GP010.003		Extraction	Quarry	Post-medieval	Quarry, later used as a pond, as shown on the 1849 Ordnance Survey map.	Figures 24, 25, 27 and 28	360472 400231

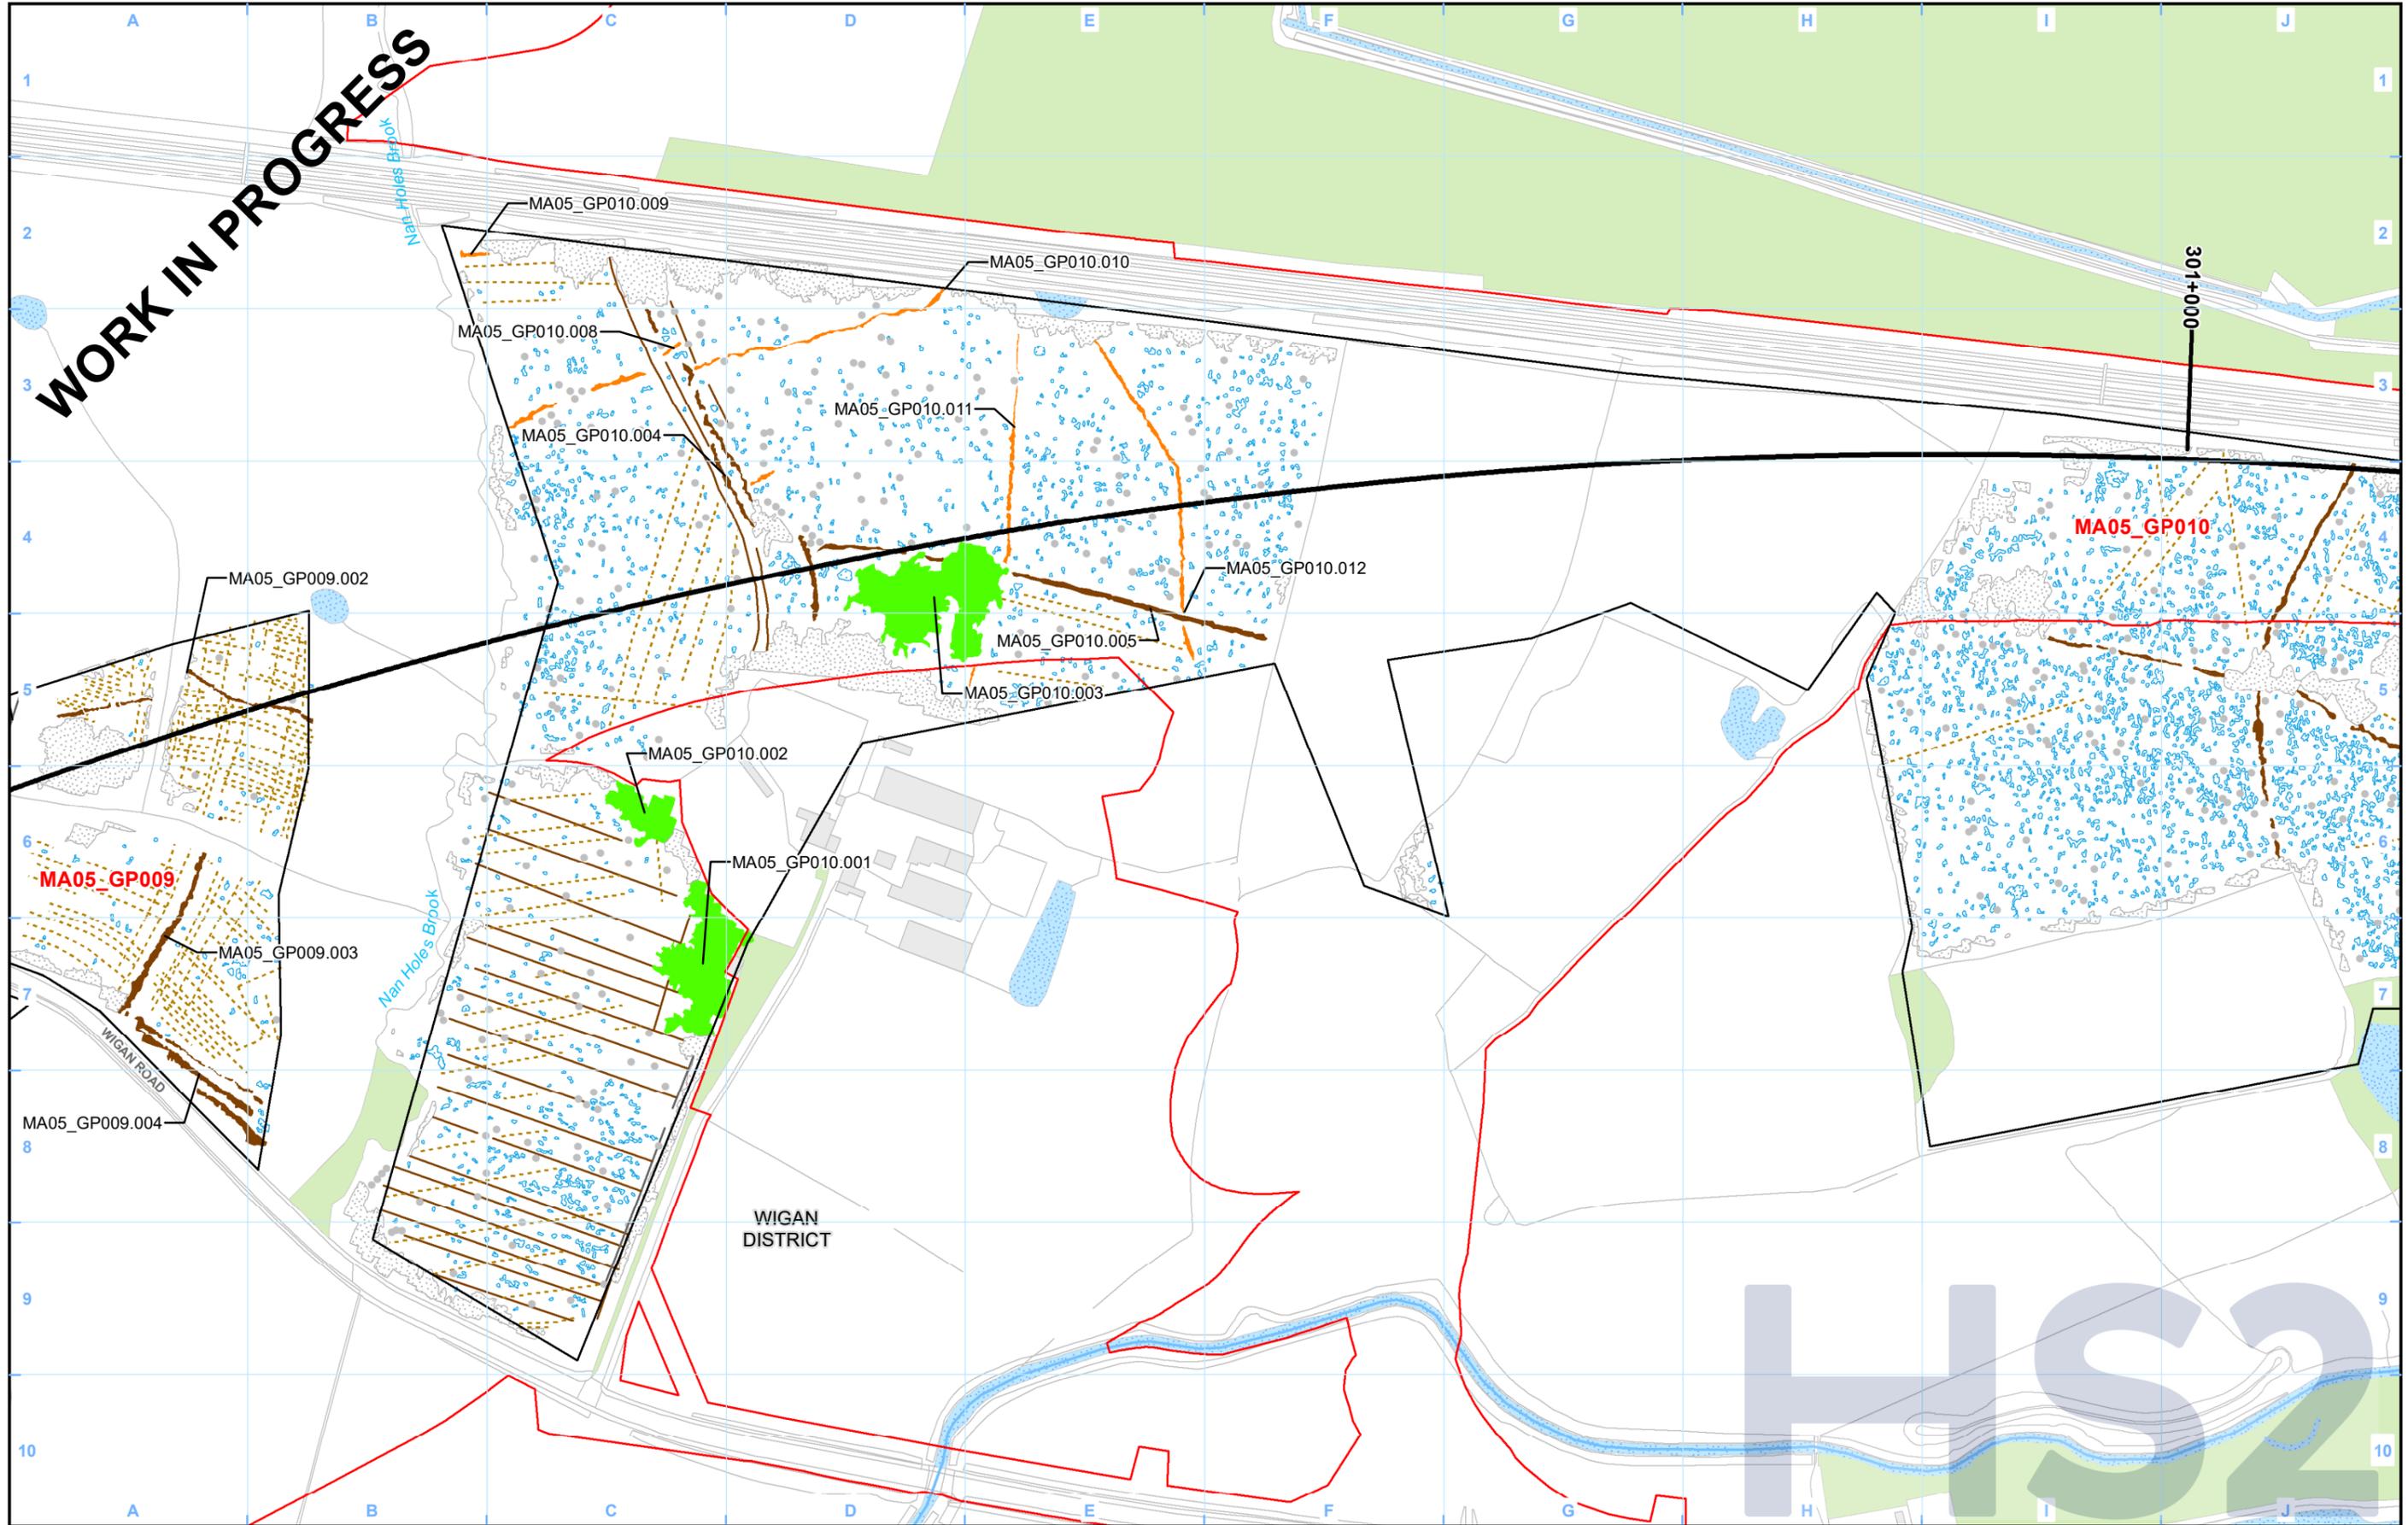
Map Number HE-004_MA05_Figure28
 Map Name Site MA05_GP010 Interpretation
 Community Area MA05: Risley to Bamfurlong

- 3.9.4 Three areas of high magnetic disturbance located at the south of the survey area close to Aye Bridge Farm correspond with former marl pits (see Footnote 15) (see Figures 24 to 28, anomalies MA05_GP010.001 to MA05_GP010.003) depicted on the 1849 Ordnance Survey map¹³ later used as a ponds. The disturbance was caused by the magnetic properties (brick, tile, iron etc.) of the material used to infill the former ponds.

Reference	Asset UID	Anomaly category	Feature type	Period	Comment	Figure	NGR
					Disturbance likely caused by magnetic objects within backfill.		
MA05_GP010.004		Agricultural historic	Field boundary	Post-medieval	A former field boundary depicted on the on 1849 Ordnance Survey map.	Figures 24, 25, 27 and 28	360457 400136
MA05_GP010.005		Agricultural historic	Field boundary	Post-medieval	A former field boundary depicted on the on 1849 Ordnance Survey map.	Figures 27 and 28	360446 400314
MA05_GP010.006		Agricultural historic	Field boundary	Post-medieval	A former field boundary depicted on the on 1849 Ordnance Survey map.	Figures 30 and 31	360326 400830 360326 400713
MA05_GP010.007		Agricultural historic	Field boundary	Post-medieval	A former field boundary depicted on the on 1849 Ordnance Survey map.	Figures 30 and 31	360259 400760 360343 400768
MA05_GP010.008	MA05_0164	Archaeology possible		Undated	Anomaly of possible archaeological origin due to highly magnetic response. May represent former field boundary removed before the earliest available mapping of the area was produced.	Figures 24, 25, 27 and 28	360412 400094
