High Speed Rail (Crewe – Manchester)

Water resources and flood risk

BID WR-002-00001_Part 1

Water Framework Directive compliance
assessment baseline data - Part 1 of 2

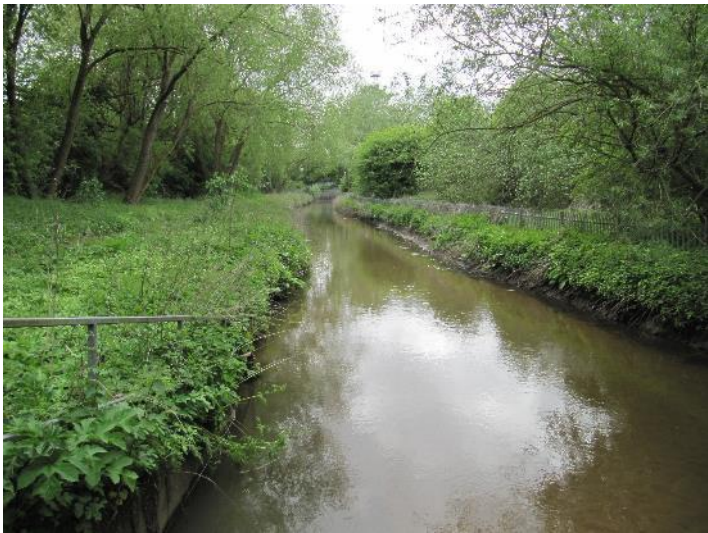
<p>Photograph taken from NGR SJ7122255178</p>

Baseline description	Example photograph
<p>Upstream of Proposed Scheme</p> <p>Flow: Glide, run</p> <p>Substrate: Sand</p> <p>Riparian vegetation: Scrub and broadleaf vegetation on both banks, some overhanging vegetation, slight channel shading</p> <p>Morphological pressures / modifications: Straight channel between culverts up and downstream. Low gradient and highly modified in centre of Crewe. Very low habitat value. No macrophytes, silty, limited fish habitat</p> <p>Land use: Urban (with park areas)</p>

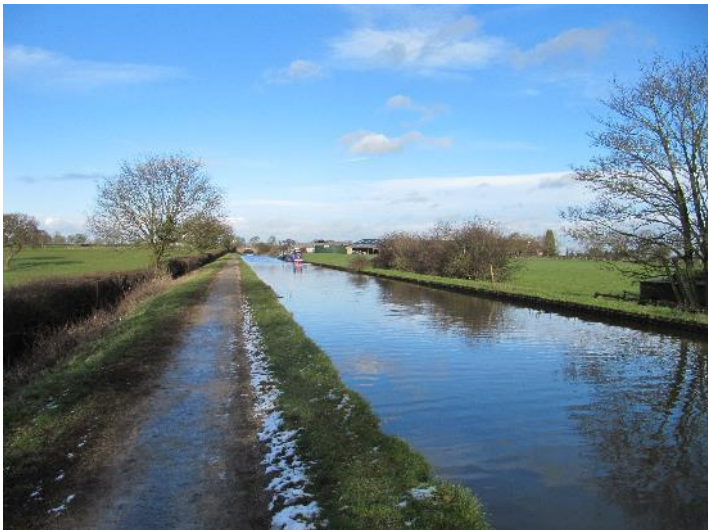
<p>Photograph taken from NGR SJ6820065100</p>

Baseline description	Example photograph
<p>Upstream of Proposed Scheme</p> <p>Flow: Impounded by canal locks</p> <p>Substrate: Not visible but expected to be a mixture of silt, sand and clay</p> <p>Riparian vegetation: Grasses on both banks, no low overhanging vegetation, occasional shading from isolate trees</p> <p>Morphological pressures / modifications: Canal - reinforced banks</p> <p>Land use: Improved and rough pasture, arable and scrub</p>

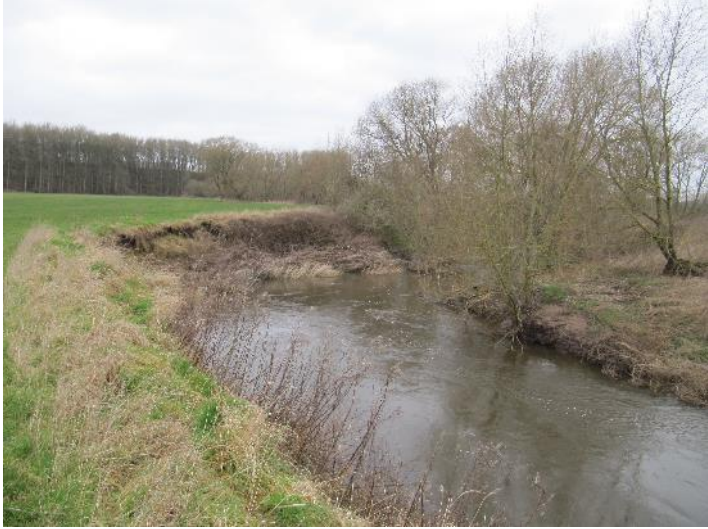
Baseline description	Example photographs
<p>Upstream of Proposed Scheme</p> <p>Flow: Glides and runs, with pools</p> <p>Substrate: Clay, coarse and fine gravel, sand and silt</p> <p>Riparian vegetation: Scrub and shrub, little overhanging vegetation and slight channel shading from isolated trees</p> <p>Morphological pressures / modifications: Land use - grazing to bank top and lack of tree-line contributing to erosion processes</p> <p>Land use: Improved pasture and scrub, with occasional pockets of broadleaf woodland</p>

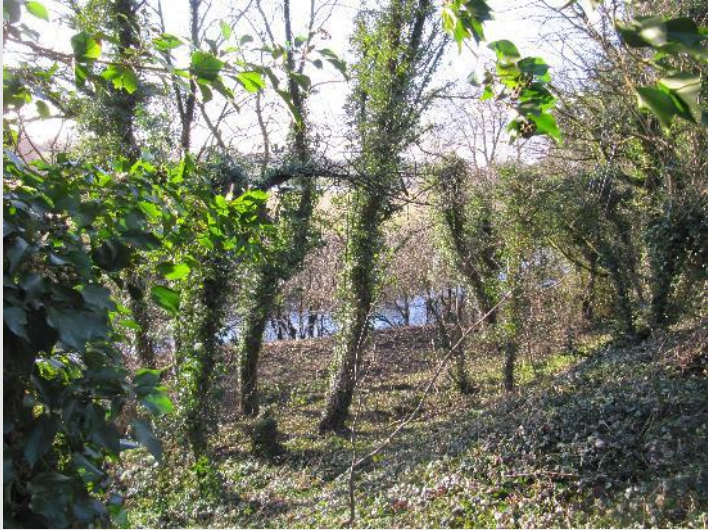
<p>Photograph taken from NGR SJ6830068200</p>

<p>Photograph taken from NGR SJ6860067900</p>
<p>At location of Proposed Scheme</p> <p>Flow: Glides and runs, with pools</p> <p>Substrate: Clay, coarse and fine gravel, sand and silt</p> <p>Riparian vegetation: Scrub and shrub, little overhanging vegetation, and slight channel shading</p> <p>Morphological pressures / modifications: Land use - grazing to bank top and lack of tree-line contributing to erosion processes</p> <p>Land use: Broadleaf woodland, improved pasture and scrub</p>

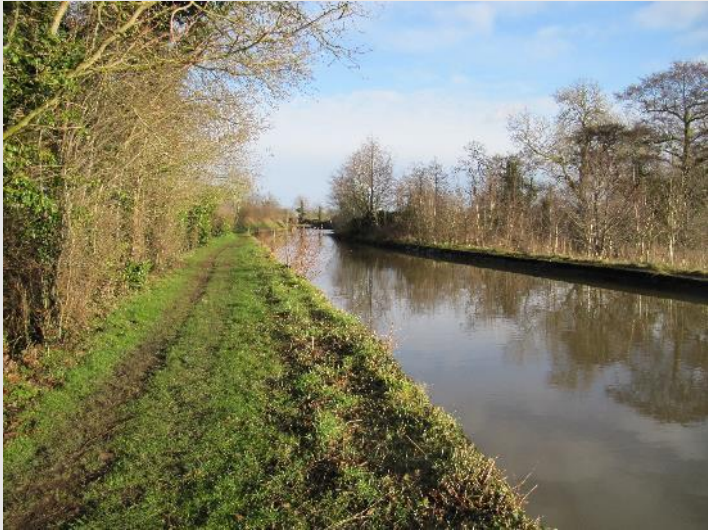
Baseline description	Example photograph
<p>At location of Proposed Scheme – Crossing 2</p> <p>Flow: Impounded by canal locks</p> <p>Substrate: Not visible but expected to be silt, sand and clay</p> <p>Riparian vegetation: Broadleaf vegetation on right bank, grasses on left bank, no low overhanging vegetation and slight channel shading</p> <p>Morphological pressures / modifications: Canal - reinforced banks</p> <p>Land use: Improved pasture, broadleaf woodland, arable and scrub</p>

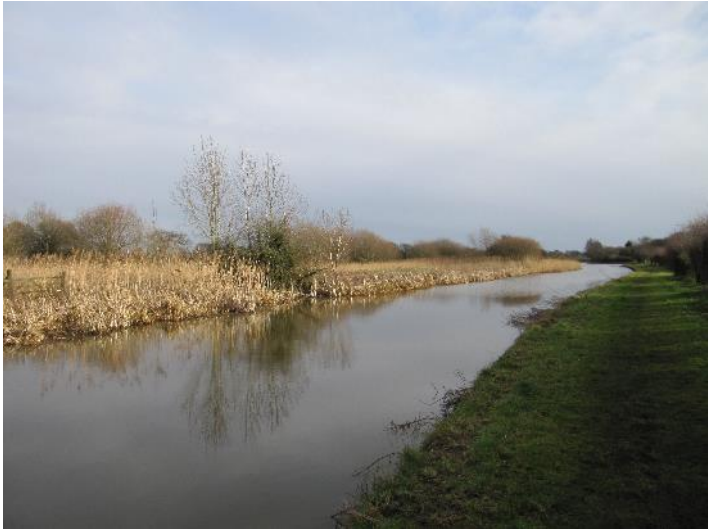
<p>Photograph taken from NGR SJ6850068700</p>

<p>Photograph taken from NGR SJ6830070300</p>
<p>At location of Proposed Scheme – Crossing 3</p> <p>Flow: Impounded by canal locks. Large backwaters formed from subsidence</p> <p>Substrate: Not visible but expected to be silt, sand and clay</p> <p>Riparian vegetation: Grasses on both banks, reedbed margin on right bank and slight channel shading</p> <p>Morphological pressures / modifications: Canal - reinforced banks</p> <p>Land use: Improved pasture, arable, woodland, scrub and wetland</p>

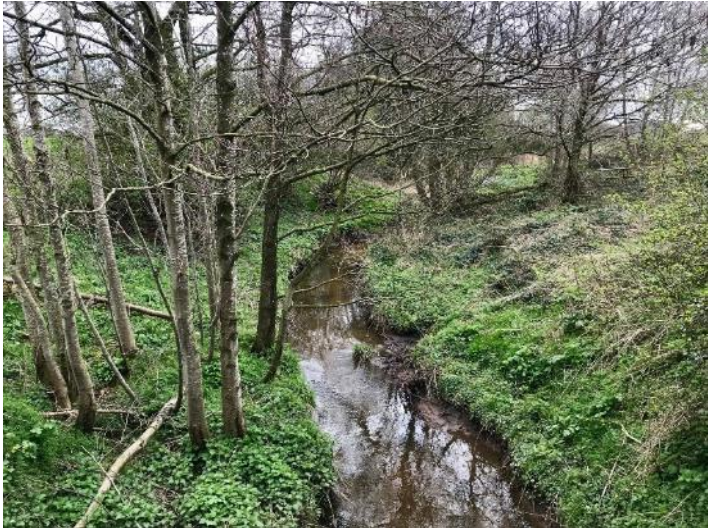
<p>Photograph taken from NGR SJ6842870075</p>

Baseline description	Example photograph
<p>At location of Proposed Scheme</p> <p>Flow: Run, glide, riffle and pool</p> <p>Substrate: Coarse gravel, cobbles, fine gravel, sand, silt and clay</p> <p>Riparian vegetation: Broadleaf trees on both banks, some overhanging vegetation and high channel shading</p> <p>Morphological pressures / modifications: Culvert under canal (possible siphon). Planform constrained by canal embankment. Disconnected from floodplain due to steep high banks - possibly historically modified as well as local topography. Localised bank undercutting. Small culverts for farm tracks</p> <p>Land use: Improved pasture and broadleaf woodland, some arable and scrub</p>

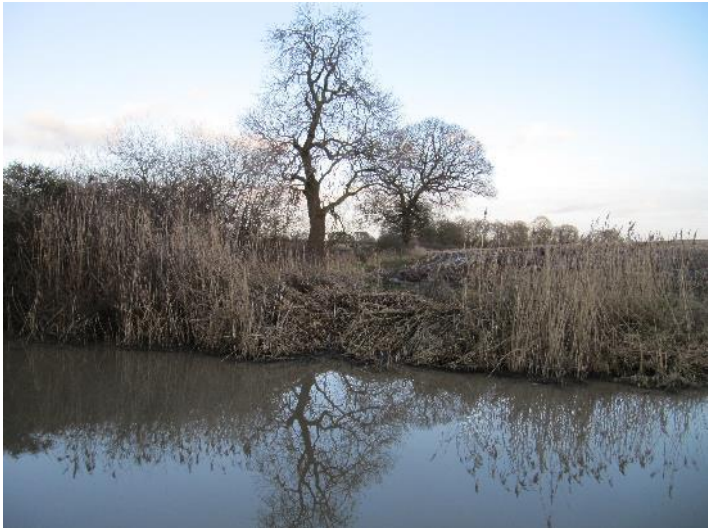
<p>Photograph taken from NGR SJ6805269349</p>

Baseline description	Example photograph
<p>At location of Proposed Scheme Small watercourse/field ditch (note: watercourse enters Trent and Mersey Canal on opposite bank from photo location)</p>

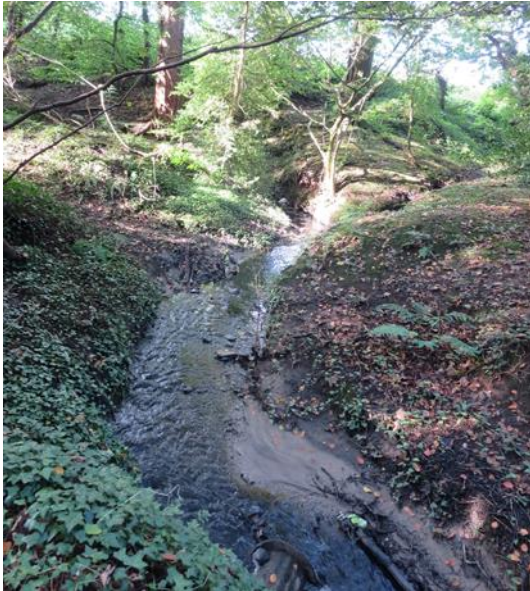
<p>Photograph taken from NGR SJ7018075530</p>

Baseline description	Example photograph
<p>At location of Proposed Scheme</p> <p>Flow: Run, glide, riffles, pools</p> <p>Substrate: Silt, with some coarse gravel, fine gravel, sand and clay. Some exposed bedrock in places</p> <p>Riparian vegetation: Broadleaf trees on both banks, some overhanging vegetation, moderate channel shading</p> <p>Morphological pressures / modifications: None in survey location, flows under A559 upstream of survey location</p> <p>Land use: Broadleaf woodland</p>

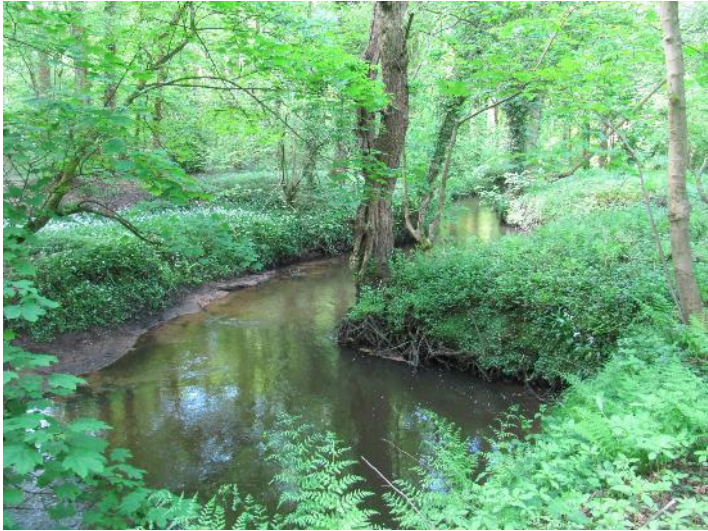
<p>Photograph taken from NGR SJ7022075680</p>

Baseline description	Example photograph
<p>At location of Proposed Scheme</p> <p>Flow: Glide, run, pools</p> <p>Substrate: Sand, coarse and fine gravel, silt and clay</p> <p>Riparian vegetation: Broadleaf trees on both banks, some overhanging vegetation and high channel shading</p> <p>Morphological pressures / modifications: None in survey location, straightened further upstream alongside A559</p> <p>Land use: Broadleaf woodland and some arable</p>

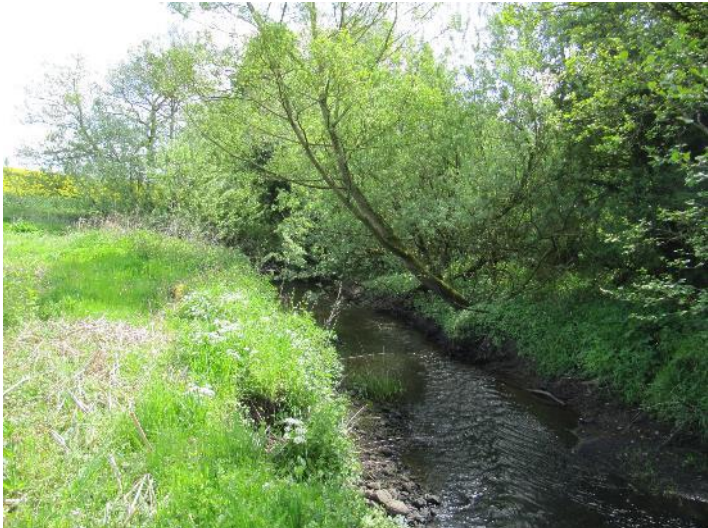
<p>Photograph taken from NGR SJ7069778672</p>

Baseline description	Example photograph
<p>At location of Proposed Scheme</p> <p>Flow: Run, glide, riffles, pools</p> <p>Substrate: Coarse and fine gravel and cobbles</p> <p>Riparian vegetation: Grasses on right bank, broadleaf trees on left bank, some low overhanging vegetation and high channel shading</p> <p>Morphological pressures / modifications: Existing bridge crossing at Budworth Road/Waterless Bridge - no clear impact on morphology</p> <p>Land use: Improved pasture, scrub, woodland and arable</p>

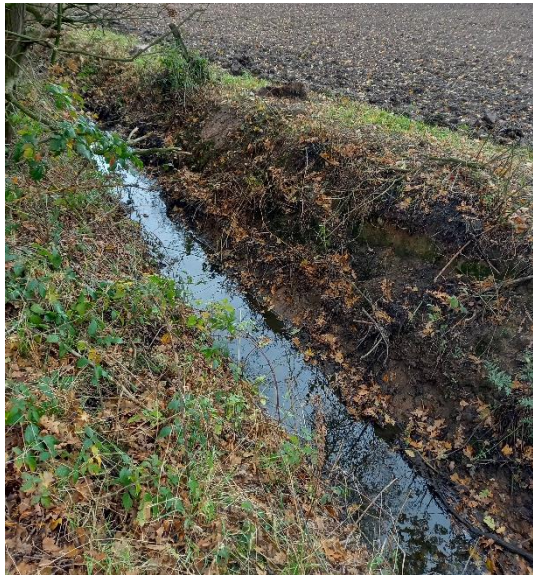
<p>Photograph taken from NGR SJ7108582707</p>

Baseline description	Example photograph
<p>Upstream of Proposed Scheme</p> <p>Straight, field drainage ditch</p> <p>Over-deep</p> <p>Several short culverts beneath field access tracks</p> <p>Bare, exposed earth banks and intermittent tree cover</p> <p>Some fine gravels on bed but predominantly silts</p> <p>Low flow velocities and shallow</p> <p>Bare earth at base of banks suggests recent channel excavation</p> <p>Shallow field ditch shaded by tall ruderal vegetation. Low habitat potential</p>

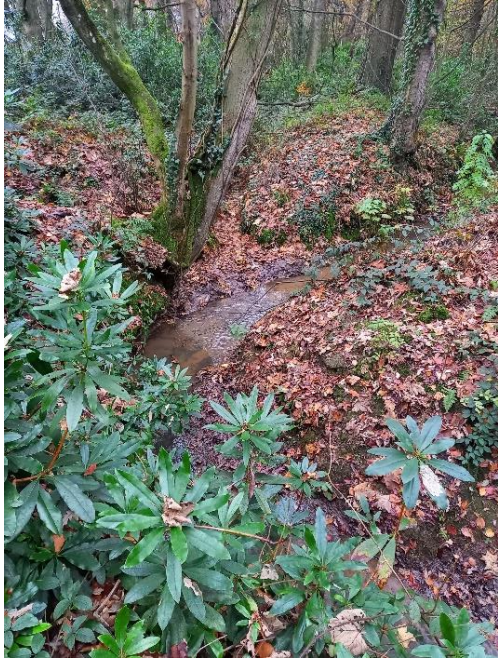
Baseline description	Example photograph
<p>Downstream of Proposed Scheme: upstream section through woodland</p> <p>Typically, field drainage ditch with some sinuosity in woodland</p> <p>Watercourse in woodland is heavily shaded, with substantial leaf litter and silty substrate</p> <p>Roots and undercut banks</p> <p>Very turbid and bed choked with fine sediment – likely to be dry in summer</p>

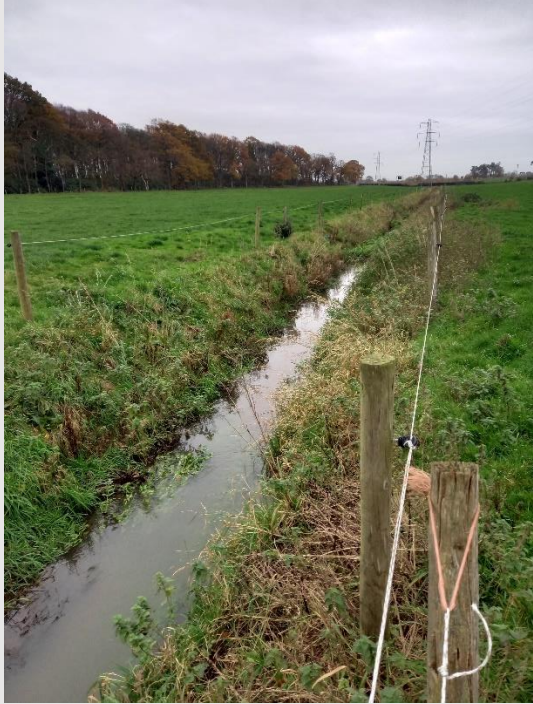
<p>Photography taken from NGR SJ7176581109</p>

<p>Photograph taken from NGR SJ7179181768</p>
<p>Downstream of Proposed Scheme: downstream surveyed section through farmland</p> <p>Becomes more of a straight, field ditch downstream</p> <p>Some sections with very scarce riparian vegetation</p> <p>Several culverts and small pond area</p> <p>Some submerged and emergent plant species and limited flow variation</p>

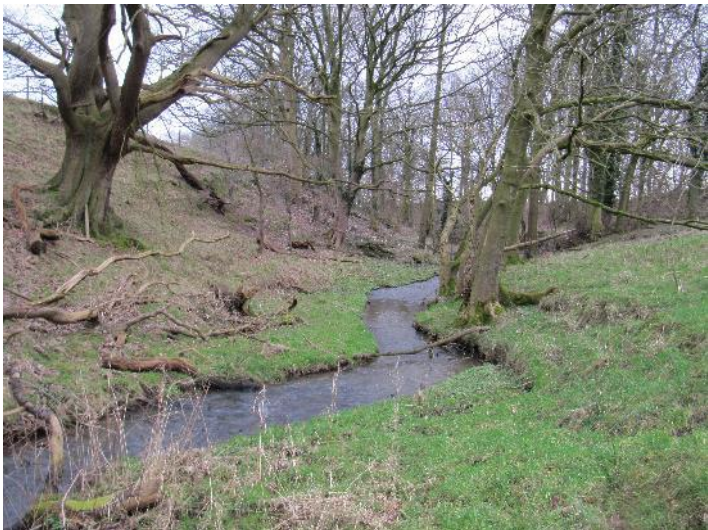
<p>Photograph taken from NGR SJ7230084200</p>

Baseline description	Example photograph
<p>At location of Proposed Scheme</p> <p>Flow: Riffles, glide, run</p> <p>Substrate: Coarse and fine gravel, and cobbles</p> <p>Riparian vegetation: Broadleaf trees on both banks, some overhanging vegetation and moderate channel shading</p> <p>Morphological pressures / modifications: No clear pressures within area surveyed</p> <p>Land use: Improved and rough pasture, broadleaf woodland</p>

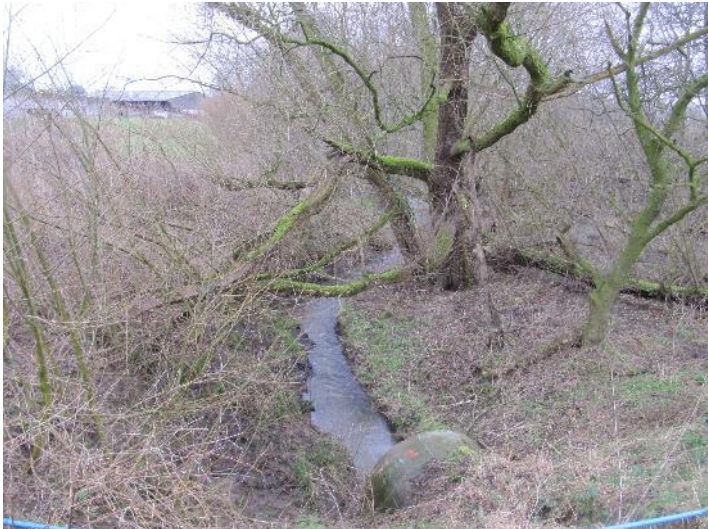
Baseline description	Example photograph
<p>Downstream of Proposed Scheme</p> <p>Flow: Glide, run, riffles, pools</p> <p>Substrate: Coarse and fine gravel, silt and clay</p> <p>Riparian vegetation: Broadleaf trees on right bank and herbaceous on left bank, some overhanging vegetation and high channel shading</p> <p>Morphological pressures / modifications: Substantial pipe culvert, and road bridge at end of reach</p> <p>Land use: Mixed woodland, scrub and improved pasture</p>

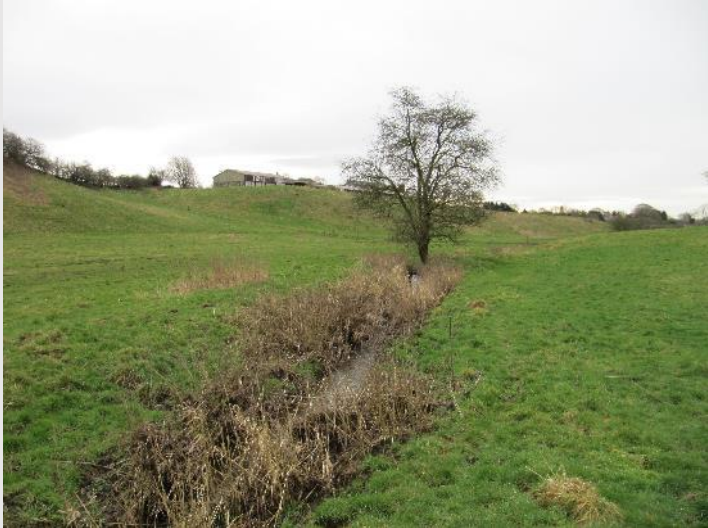
<p>Photograph taken from NGR SJ7245384840</p>

<p>Photograph taken from NGR SJ7190086300</p>
<p>At location of Proposed Scheme</p> <p>Flow: Glide, run, riffles</p> <p>Substrate: Silt, sand, clay and fine gravel</p> <p>Riparian vegetation: Herbaceous on both banks, some overhanging vegetation and slight channel shading</p> <p>Morphological pressures / modifications: Road bridges and culverts at downstream end, some straightened sections upstream</p> <p>Land use: Improved and rough pasture, with scrub and woodland and urban/suburban</p>

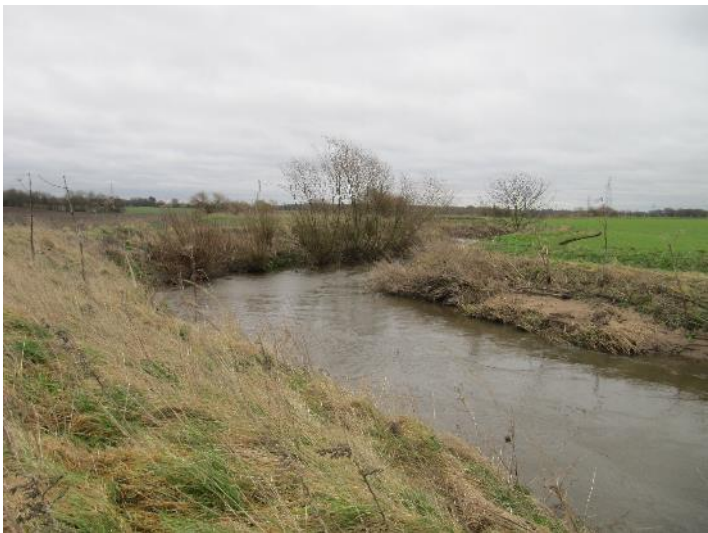
<p>Photograph taken from NGR SJ7126888131</p>

Baseline description	Example photograph
<p>At location of Proposed Scheme</p> <p>Flow: Glide, run</p> <p>Substrate: Sand, coarse and fine gravel, silt and clay</p> <p>Riparian vegetation: Herbaceous on both banks, little overhanging vegetation and slight channel shading</p> <p>Morphological pressures / modifications: Embankments and over-deepening mean watercourse is not active and is relatively uniform despite meandering planform</p> <p>Land use: Arable with some scrub</p>

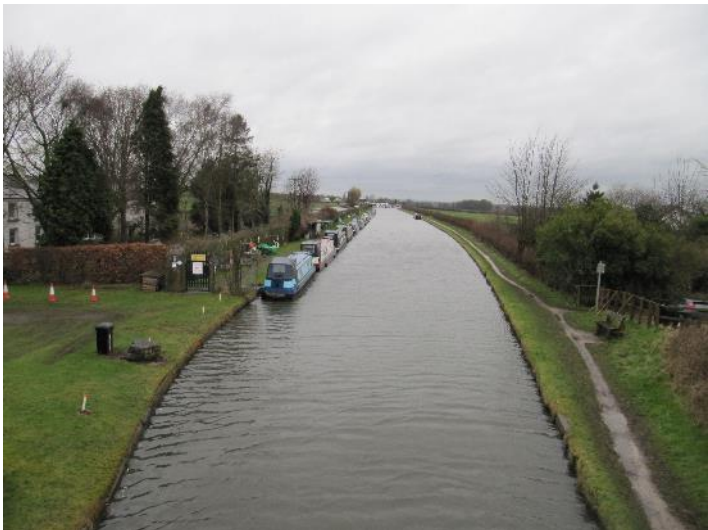
<p>Photograph taken from NGR SJ7160686672</p>

Baseline description	Example photograph
<p>At location of Proposed Scheme</p> <p>Flow: Ponded reach</p> <p>Substrate: Expected to be silty</p> <p>Riparian vegetation: Grass on both banks, no overhanging vegetation and no channel shading</p> <p>Morphological pressures / modifications: Canal - reinforced banks</p> <p>Land use: Improved pasture, amenity grassland and urban/suburban</p>

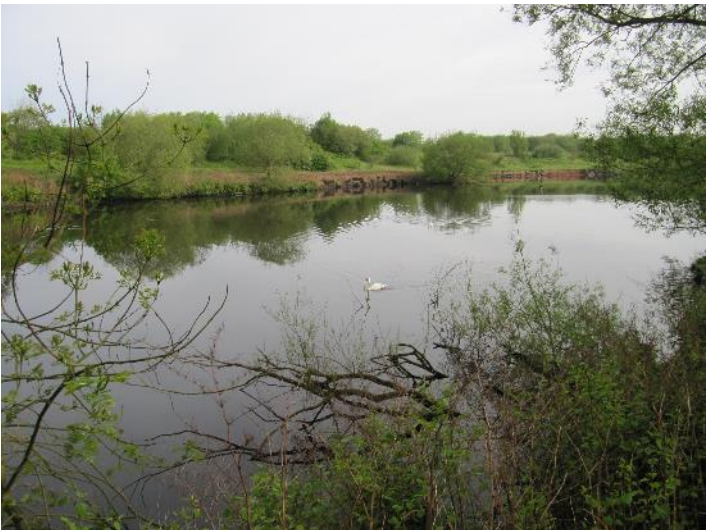
<p>Photograph taken from NGR SJ7003390913</p>

Baseline description	Example photograph
<p>At location of Proposed Scheme</p> <p>Flow: Impounded reach</p> <p>Substrate: Obscured</p> <p>Riparian vegetation: Broadleaf trees on both banks, some low overhanging vegetation and slight channel shading</p> <p>Morphological pressures / modifications: Canalised reach with large earth embankments and majority hard banks at toe. Impounded by downstream lock structures</p> <p>Land use: Scrub, industrial, urban/suburban, amenity grassland rough and improved pasture and woodland</p>

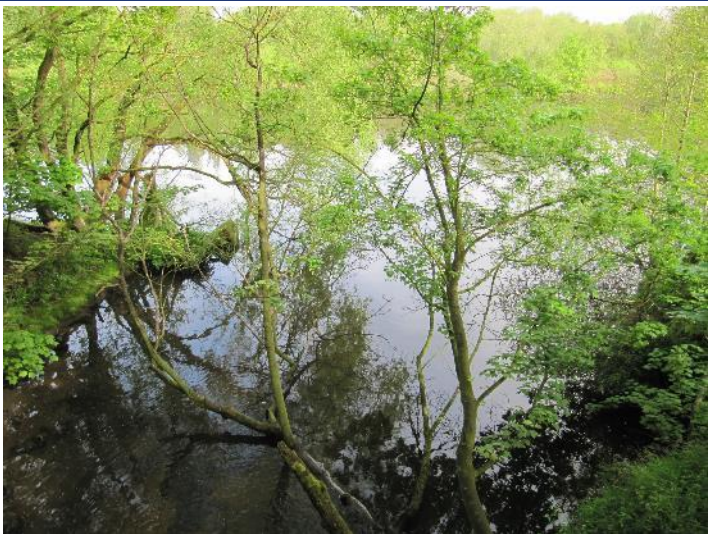
<p>Photograph taken from NGR SJ7001990804</p>
<p>At location of Proposed Scheme</p> <p>Similar condition to downstream section</p>

Baseline description	Example photograph
<p>Downstream of Proposed Scheme</p> <p>Flow: Glide, run, pools, riffles</p> <p>Substrate: Silt, coarse and fine gravel</p> <p>Riparian vegetation: Broadleaf trees on both banks, some low overhanging vegetation and high channel shading</p> <p>Morphological pressures / modifications:</p> <p>Footbridge at downstream extent near confluence with Manchester Ship Canal/Mersey</p> <p>Land use: Broadleaf woodland, improved pasture, arable and scrub</p>

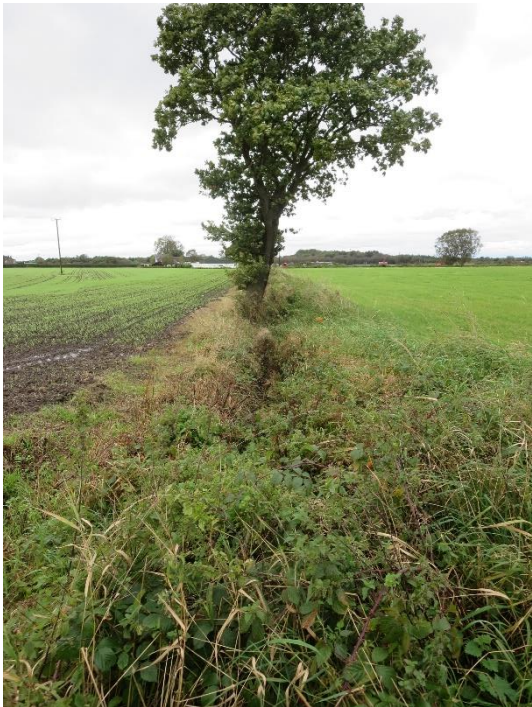
<p>Photograph taken from NGR SJ6789092700</p>

Baseline description	Example photograph
<p>Upstream of Proposed Scheme Small overgrown field ditch through agricultural land. Some reaches recently dredged/cleared</p>

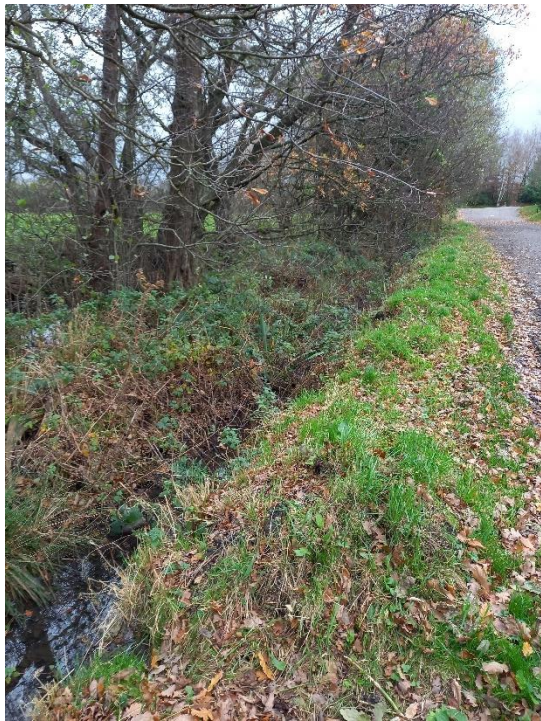
<p>Photograph taken from NGR SJ6454594781</p>

Baseline description	Example photograph
<p>Upstream of Proposed Scheme</p> <p>Straight drainage ditch</p> <p>Informal embankment along right bank; assumed to be dredged material left and vegetated over</p> <p>Very low flow and low energy</p> <p>Silty substrate and turbid</p> <p>Long culverted section (>200m)</p> <p>Limited riparian vegetation cover; heavily managed through farmland</p> <p>Heavily managed field ditch with low habitat potential</p>

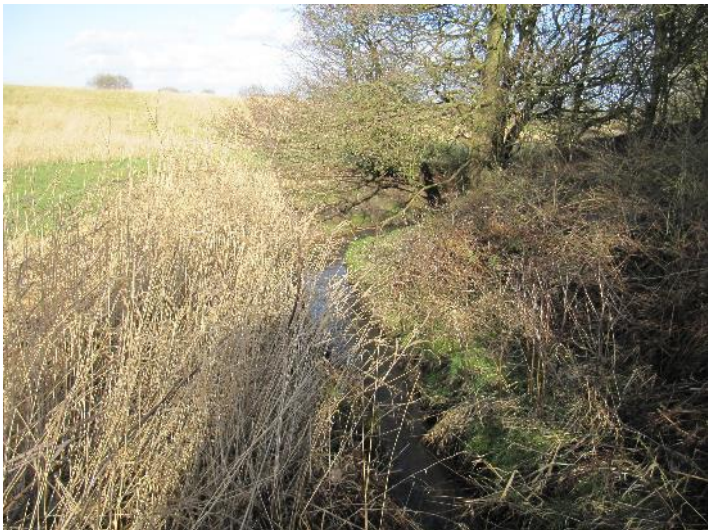
<p>Photograph taken from NGR SJ6090099800</p>

Baseline description	Example photograph
<p>Downstream of Proposed Scheme</p> <p>Flow: Riffle, pool, run</p> <p>Substrate: Coarse and fine gravel, cobbles</p> <p>Riparian vegetation: Broadleaf vegetation on right bank, herbaceous on left bank, some overhanging vegetation and high channel shading</p> <p>Morphological pressures / modifications: Culvert downstream</p> <p>Land use: Mixed woodland, scrub and improved pasture</p>

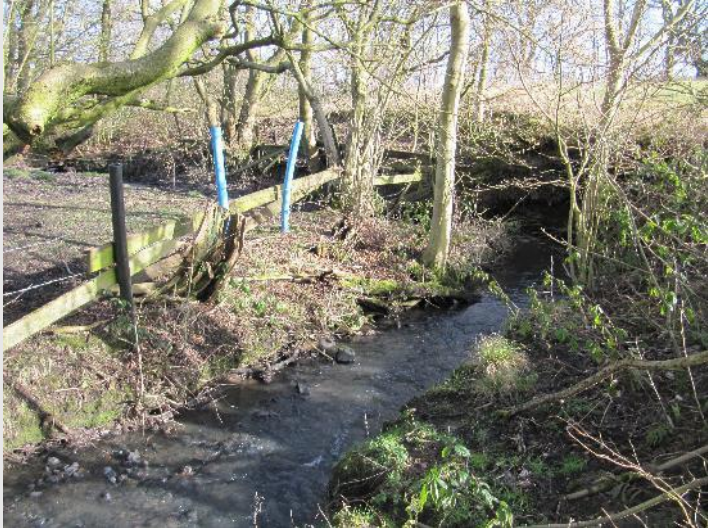
<p>Photograph taken at NGR SD6060000100</p>

Table 85: Summary of baseline condition of Nan Holes Brook within the vicinity of the Proposed Scheme

Baseline description	Example photograph
<p>Upstream of Proposed Scheme</p> <p>Flow: Glide, ponded</p> <p>Substrate: Silt, sand and artificial</p> <p>Riparian vegetation: Grasses and scrub/shrubs. Uniform and managed</p> <p>Morphological conditions and pressures / modifications: Straight drainage ditch</p> <p>Over-deep channel and informal embankment on both banks (likely excavated material). Silty bed substrate.</p> <p>Limited flow. Long culvert >10m, partially blocked</p> <p>Land use: Arable farmland</p>	  <p>Photograph taken at NGR SJ5965699876</p>
<p>At location of Proposed Scheme</p> <p>Flow: Riffles, pools, run</p> <p>Substrate: Coarse and fine gravel, cobbles</p> <p>Riparian vegetation: Herbaceous on right bank and broadleaf vegetation on left bank, some overhanging vegetation and high channel shading</p> <p>Morphological pressures / modifications: Existing culverts 200m downstream under A573 Wigan Road, and 200m upstream under WCML (not visible during survey)</p> <p>Land use: Scrub and improved pasture, woodland and urban/suburban</p>

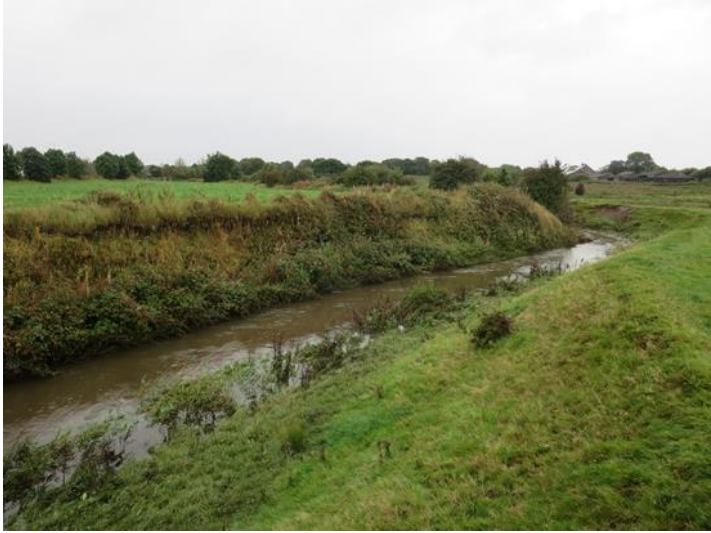
Table 87: Summary of baseline condition of Hey Brook within the vicinity of the Proposed Scheme

Baseline description	Example photograph
<p>At location of Proposed Scheme</p> <p>Flow: Glide, run, pool</p> <p>Substrate: Not visible, but assumed to be coarse and fine gravel, sand, silt and clay</p> <p>Riparian vegetation: Scrub and shrub, some low overhanging vegetation and moderate channel shading</p> <p>Morphological pressures / modifications: Historical re-sectioning (straightened/ deepened). Existing road bridge at downstream end. Some erosion/collapse of overstep banks around meander bend</p> <p>Land use: Improved and rough pasture, with scrub, within wider urban area</p>

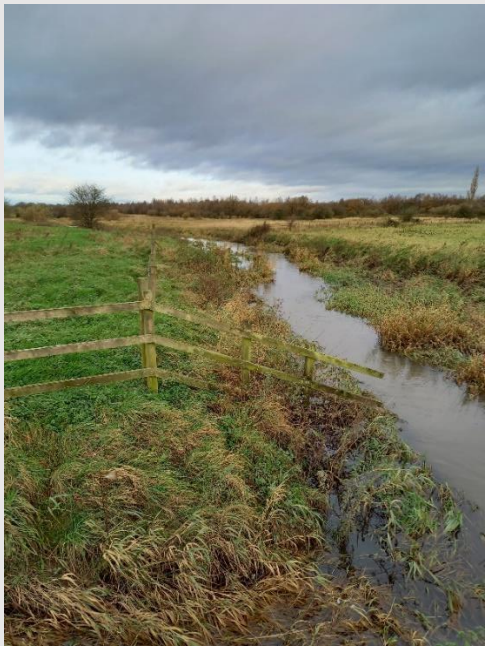
<p>Photograph taken from NGR SJ6212499473</p>

<p>Photograph taken from NGR SD6068500530</p>
<p>Downstream of Proposed Scheme</p> <p>Flow: Glide, pool</p> <p>Substrate: Very turbid (bed substrate not visible)</p> <p>Riparian vegetation: Limited riparian vegetation upstream, more tree cover further downstream with in-channel woody material and associated flow diversity</p> <p>Morphological conditions and pressures / modifications: Sinuous morphology upstream but minimal morphological diversity. Typically, very steep banks and poor connectivity. Banks vegetated and stable</p> <p>Land use: Improved pasture</p>

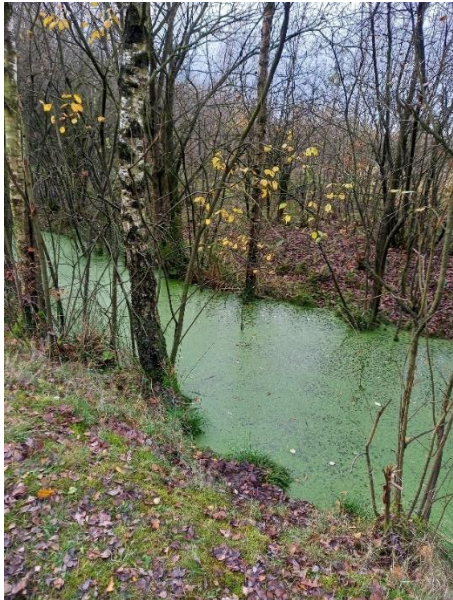
<p>Photograph taken from NGR SD6014500772</p>

Table 88: Summary of baseline condition of Tributary of Coffin Lane Brook 2 within the vicinity of the Proposed Scheme

Baseline description	Example photograph
<p>Upstream of Proposed Scheme</p> <p>Flow: Glide, ponded</p> <p>Substrate: Predominantly silts and sands with some fine gravels</p> <p>Riparian vegetation: Dense tree cover with high channel shading</p> <p>Morphological conditions and pressures / modifications: Straight, modified drainage ditch, low energy and stagnant conditions. Very low gradient and high turbidity. Dominant silty substrate, with some fine gravels upstream of culvert intake. Culvert partially infilled beneath footpath</p> <p>Land use: Grassland on adjacent floodplain. Tree lined river corridor</p>

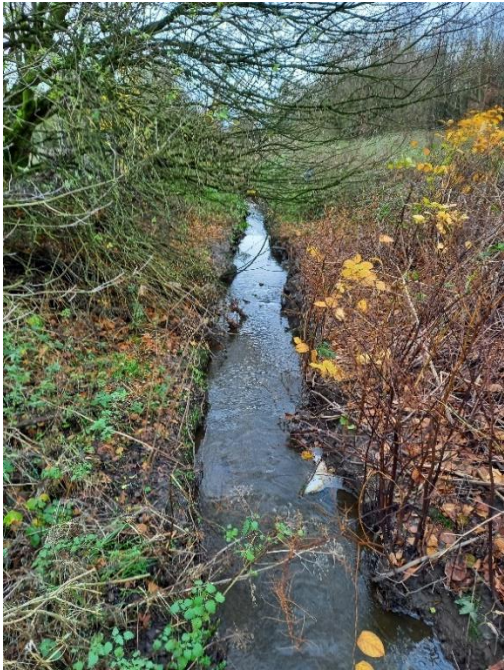
Table 89: Summary of baseline condition of Coffin Lane Brook within the vicinity of the Proposed Scheme

Baseline description	Example photograph
<p>Upstream of the Proposed Scheme</p> <p>Flow: Glide, pool, ponded</p> <p>Substrate: Predominantly silts, sands and clays, with some fine gravels identified through sinuous upstream reach</p> <p>Riparian vegetation: Broadleaf trees and shrubs/scrub, non-native species present</p> <p>Morphological conditions and pressures / modifications: Channel largely straight with some slightly sinuous sections</p> <p>Heavily modified with realigned and excavated sections. Several culverts including long culvert beneath the WCML. Very turbid upstream of WCML culvert</p> <p>Land use: Typically mixed woodland</p>

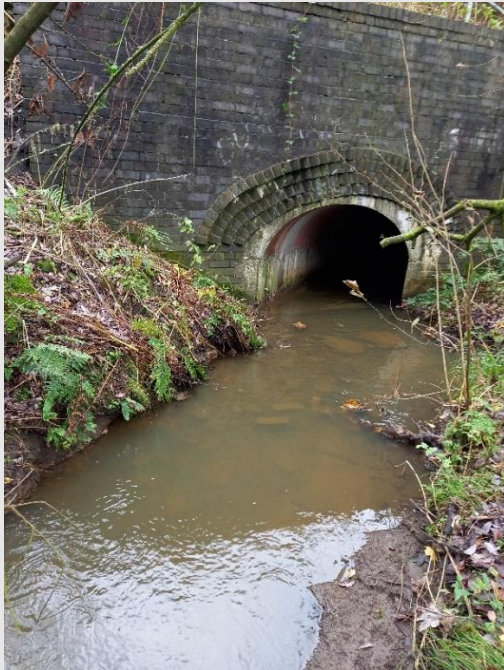
<p>Photograph taken from NGR SD6017000995</p>

<p>Photograph taken from NGR SD5911301125</p>
<p>Immediately upstream of the Proposed Scheme</p> <p>Long culvert beneath West Coast Mainline, indicating significant habitat fragmentation</p> <p>Very turbid upstream of WCML culvert. Little habitat or flow heterogeneity</p>

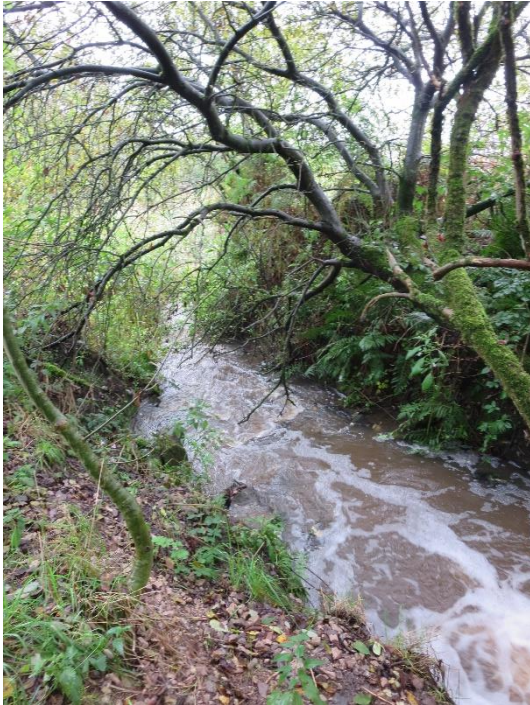
<p>Photograph taken from NGR SD5993101030</p>

Baseline description	Example photograph
<p>At location of Proposed Scheme</p> <p>Flow: Run, glide</p> <p>Substrate: Silt</p> <p>Riparian vegetation: Scrub, some overhanging vegetation and moderate channel shading</p> <p>Morphological pressures / modifications: Existing culvert under WCML</p> <p>Land use: Scrub and rough pasture</p>

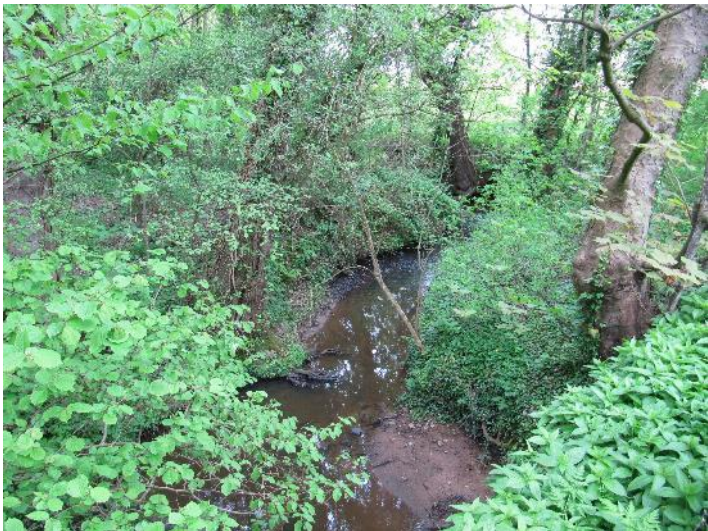
Table 95: Summary of baseline condition of Tributary of Birkin Brook 1 (Middle House Brook) within the vicinity of the Proposed Scheme

Baseline description	Example photograph
<p>At location of Proposed Scheme</p> <p>Flow: Glide, run, pools, riffles, ponds</p> <p>Substrate: Fine gravel, sand, silt and clay</p> <p>Riparian vegetation: Tree-lined, some overhanging vegetation and moderate to high channel shading</p> <p>Morphological pressures / modifications: Various existing bridges, short culverts under roads and railway, and sluices at Arden House</p>

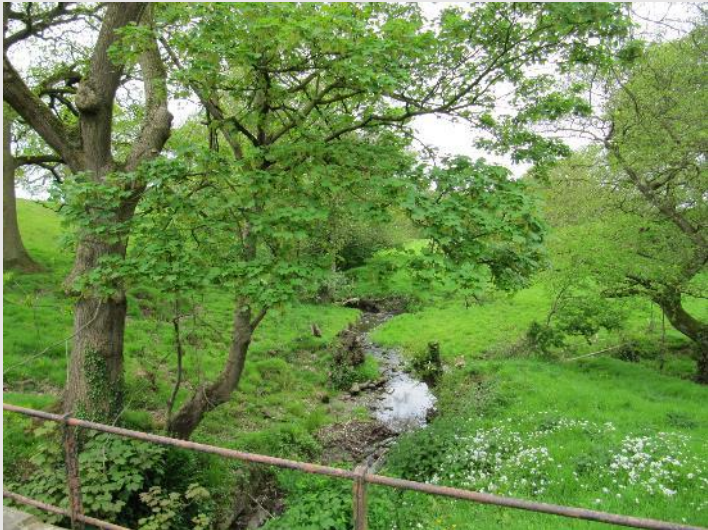
<p>Photograph taken from NGR SJ7691683728</p>

<p>Photograph taken from NGR SJ7713083678</p>
<p>Downstream of Proposed Scheme</p> <p>Flow: Glide, run, pools, riffles, ponded areas – low flow during survey</p> <p>Substrate: Coarse and fine gravel, sand, silt and clay</p> <p>Riparian vegetation: Grass on both banks, clumps of trees and moderate channel shading</p> <p>Morphological pressures / modifications: More natural than upstream</p>

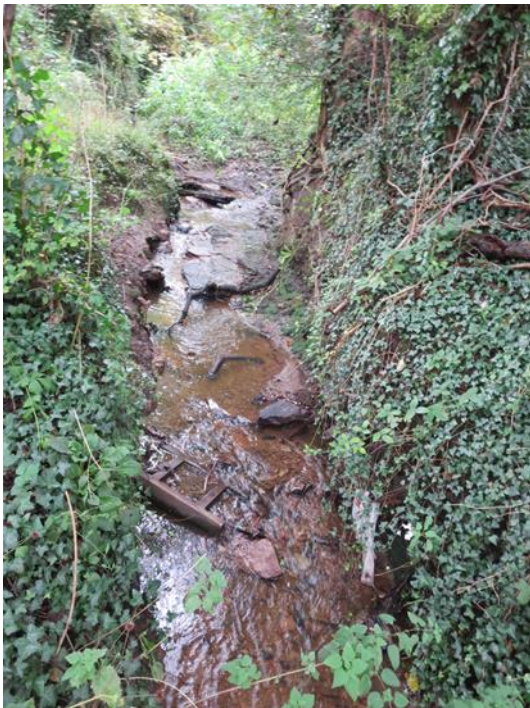
<p>Photograph taken from NGR SJ7932084360</p>

Table 98: Summary of baseline condition of Tributary of River Bollin 3 within the vicinity of the Proposed Scheme

Baseline description	Example photograph
<p>Downstream of Proposed Scheme</p> <p>Flow: Riffle, run, glide, pool, cascade</p> <p>Substrate: Coarse and fine gravel, sand, silt, clay with some exposed bedrock</p> <p>Riparian vegetation: Broadleaf trees on both banks, some low overhanging vegetation and high channel shading</p> <p>Morphological pressures / modifications: Footbridge at downstream end</p> <p>Land use: Broadleaf woodland</p>

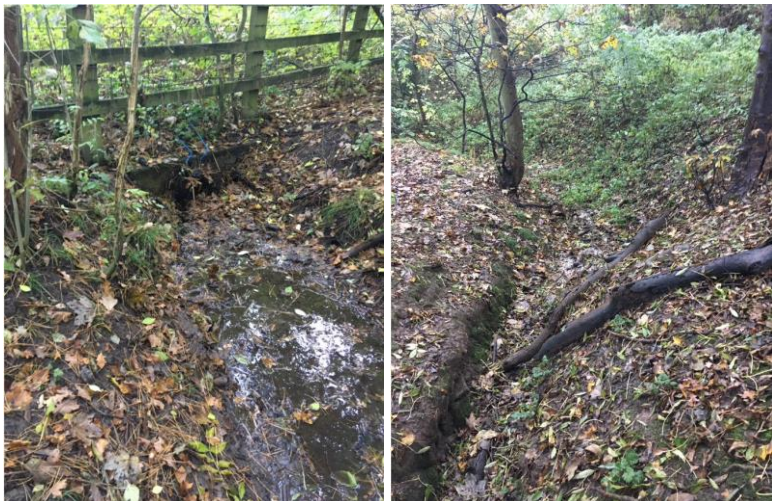
<p>Photograph taken from NGR SJ7955584544</p>

Table 99: Summary of baseline condition of Tributary of River Bollin 4 within the vicinity of the Proposed Scheme

Baseline description	Example photograph
<p>Upstream of Proposed Scheme</p> <p>Flow: Shallow flow. No distinct flow type due to minor watercourse</p> <p>Substrate: Predominantly fines/earth</p> <p>Riparian vegetation: Woodland</p> <p>Morphological pressures / modifications: Two land drainage outfalls. Turbid flow originating from outfalls. Modified, culverted section of watercourse through M56 motorway</p> <p>Land use: Scrub and woodland upstream of M56 motorway crossing</p>

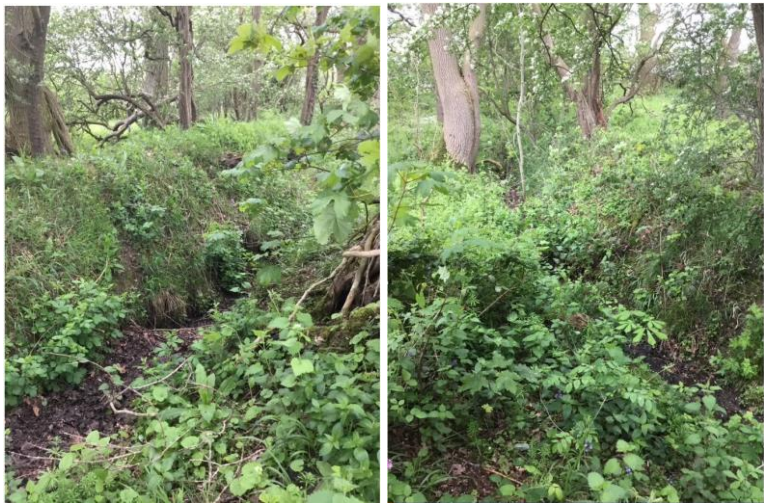
<p>Photographs taken from NGR SJ7862684637</p>

Table 100: Summary of baseline condition of Tributary of River Bollin 7 within the vicinity of the Proposed Scheme

Baseline description	Example photographs
<p>Downstream of Proposed Scheme</p> <p>Flow: Still water with no flow evident. No distinct flow type due to artificial nature of watercourse</p> <p>Substrate: Predominantly fines/earth</p> <p>Riparian vegetation: Scrub and woodland</p> <p>Morphological pressures / modifications: Artificial drainage ditch. Piped discharges into ditch predicted to be land drainage outfalls</p> <p>Land use: Wetland area with scrub and woodland, upstream of M56 motorway crossing</p>

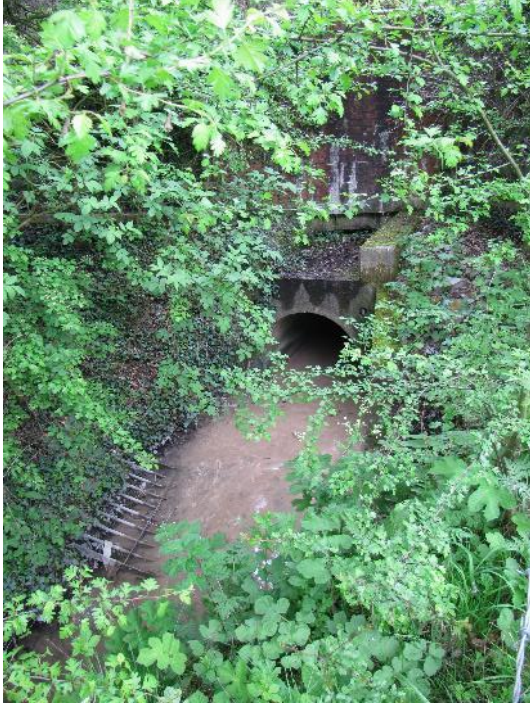
Table 102: Summary of baseline condition of Timperley Brook within the vicinity of the Proposed Scheme

Baseline description	Example photograph
<p>Upstream of Proposed Scheme</p> <p>Flow: Ponded reach between culverts</p> <p>Substrate: Silt and clay</p> <p>Riparian vegetation: Broadleaf vegetation on both banks, some low overhanging vegetation and high channel shading</p> <p>Morphological pressures / modifications: Culverted under M56, carrying runoff from Manchester Airport in upper catchment</p> <p>Land use: Improved pasture, urban/suburban and woodland</p>

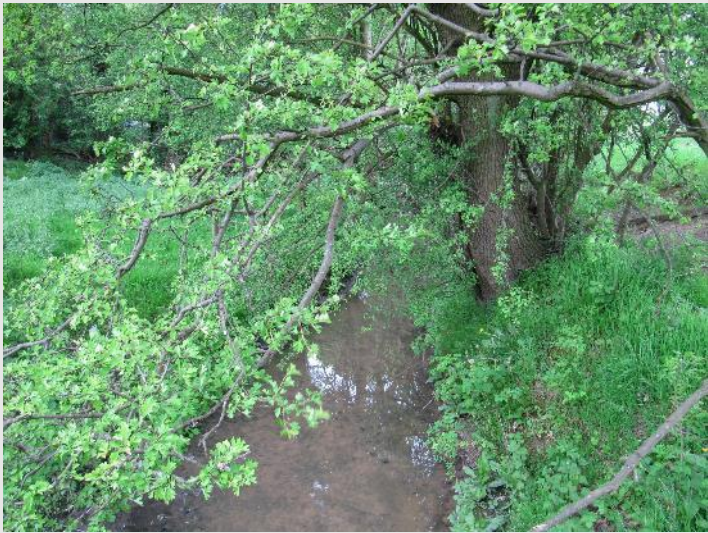
<p>Photograph taken from NGR SJ8060086003</p>
<p>At location of Proposed Scheme</p> <p>Flow: glide</p> <p>Substrate: Silt and clay</p> <p>Riparian vegetation: Broadleaf vegetation on both banks, some low overhanging vegetation and high channel shading</p> <p>Land use: Improved pasture, urban/suburban and woodland</p>

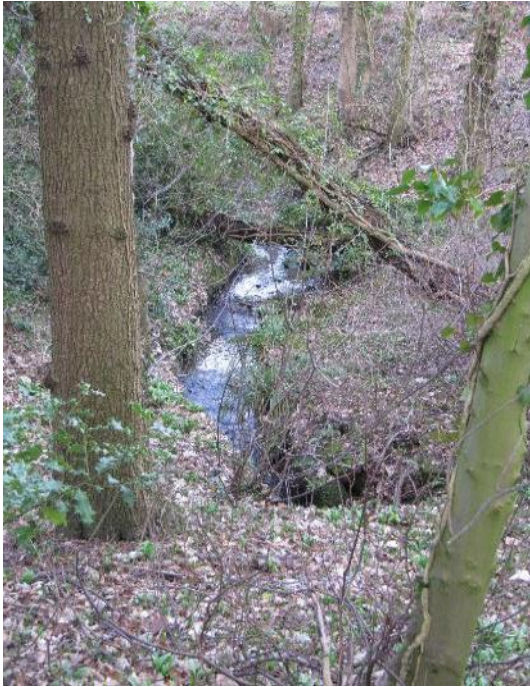
<p>Photograph taken from NGR SJ8021786160</p>

Baseline description	Example photograph
<p>Downstream of Proposed Scheme</p> <p>Flow: More free flow – shallow riffles and runs</p> <p>Substrate: Fine and coarse gravel</p> <p>Riparian vegetation: Broadleaf vegetation on both banks, some low overhanging vegetation and high channel shading</p> <p>Land use: Improved pasture, urban/suburban and woodland</p>

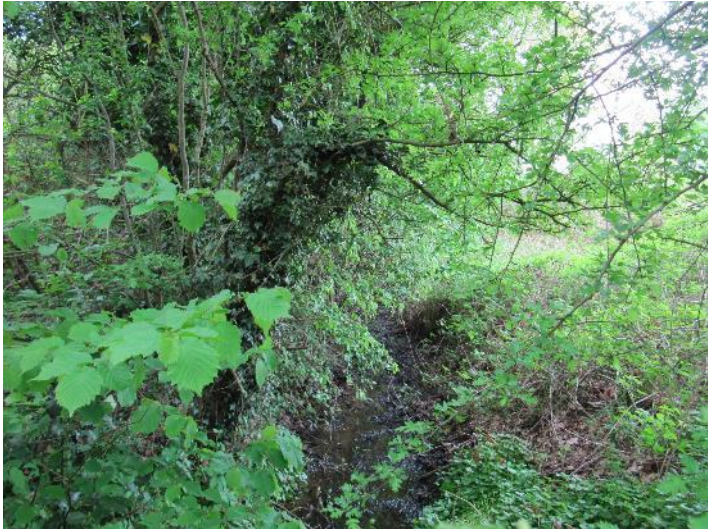
<p>Photograph taken from NGR SJ8072886961</p>

Table 103: Summary of baseline condition of Fairywell Brook within the vicinity of the Proposed Scheme

Baseline description	Example photograph
<p>At location of Proposed Scheme Very small headwater stream, little flow and overgrown by terrestrial vegetation</p>

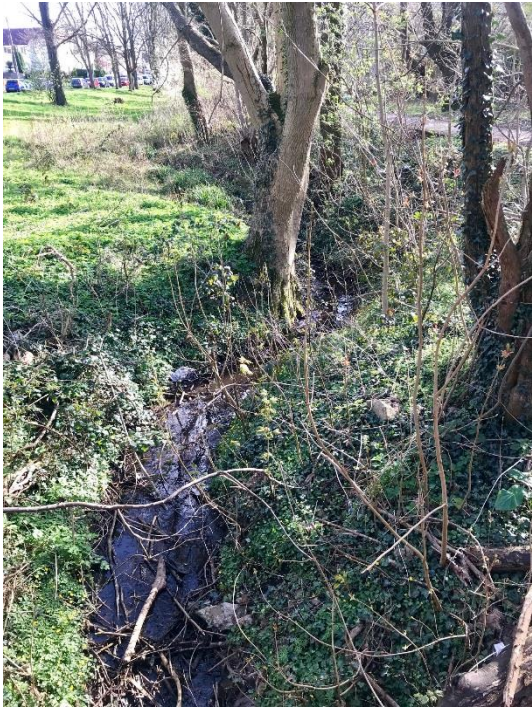
<p>Photograph taken from NGR SJ8129087600</p>

Table 104: Summary of baseline condition of Mill Brook within the vicinity of the Proposed Scheme

Baseline description	Example photograph
<p>At location of Proposed Scheme</p> <p>Flow: Run</p> <p>Substrate: Fine and coarse gravel, silt</p> <p>Riparian vegetation: Broadleaf vegetation (willow, alder), grass and scrub, some low overhanging vegetation</p> <p>Morphological pressures / modifications: Urbanised catchment, culverted approximately 150m downstream of the Proposed Scheme</p> <p>Land use: Urban/suburban, amenity grassland</p>

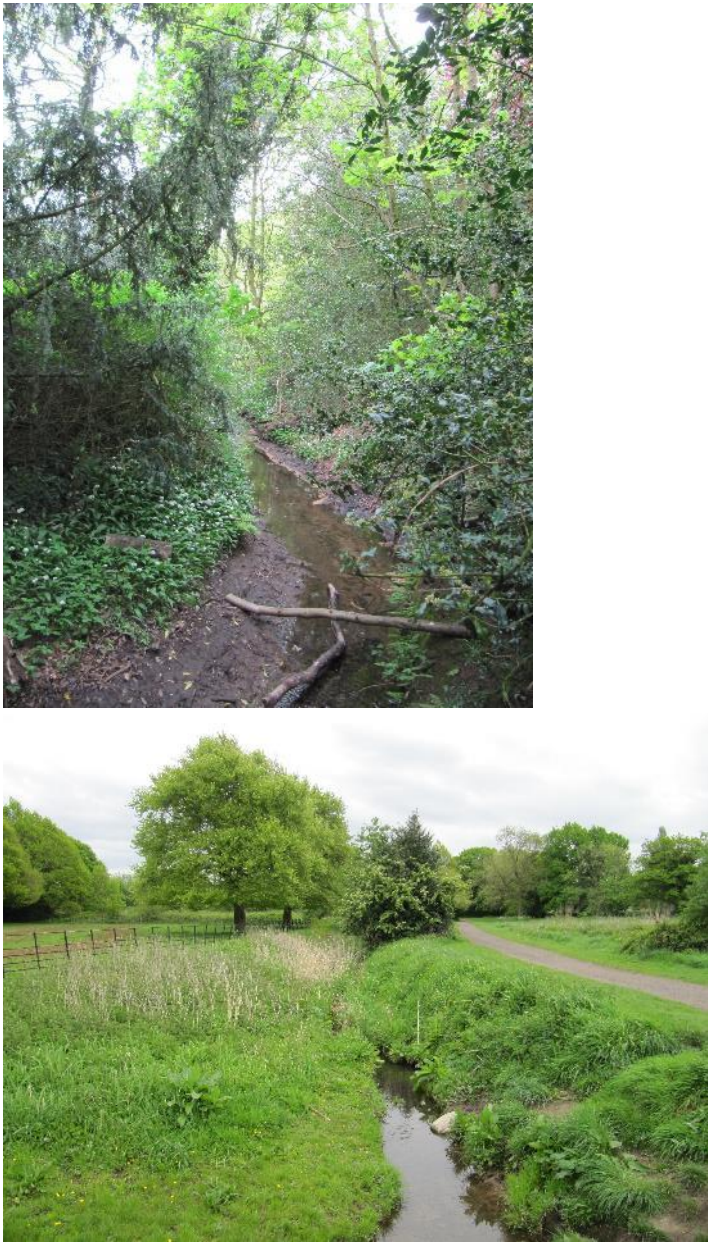
<p>Photograph taken from SJ8151789561</p>

Table 105: Summary of baseline condition of Baguley Brook within the vicinity of the Proposed Scheme

Baseline description	Example photographs
<p>Downstream of Proposed Scheme</p> <p>Flow: Run, glide</p> <p>Substrate: Gravel, fine gravel, silt</p> <p>Riparian vegetation: Grass, scrub, some woodland</p> <p>Morphological pressures / modifications: Mostly urban catchment. Straightened and deepened in places</p> <p>Land use: Urban area, parkland</p>
