High Speed Rail (Crewe – Manchester)

Water resources and flood risk

BID WR-002-00001_Part 1

Water Framework Directive compliance
assessment baseline data - Part 1 of 2

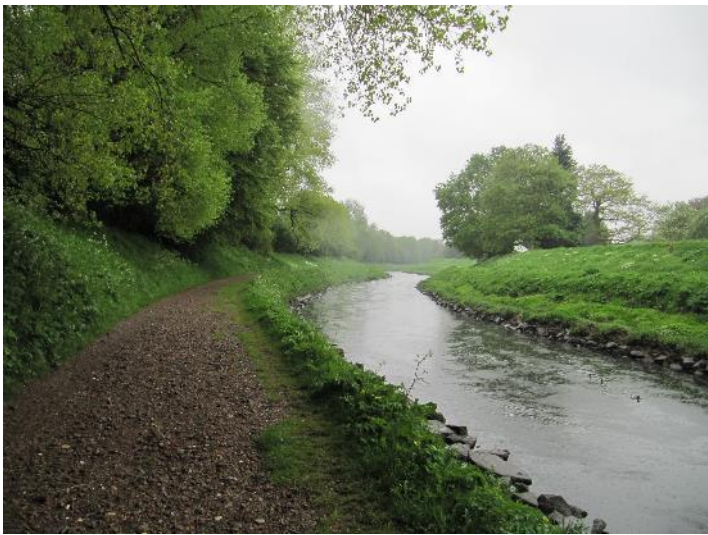
<p>Photograph taken from NGR SJ8337991733</p>

Table 106: Summary of baseline condition of River Mersey within the vicinity of the Proposed Scheme

Baseline description	Example photograph
<p>Downstream of Proposed Scheme</p> <p>Flow: Glide, run, rapid</p> <p>Substrate: Obscured by flow. Substrate likely to be mixed cobbles, coarse gravel, fine gravel, sand, silt and clay</p> <p>Riparian vegetation: Grasses on both banks, trees behind bank top</p> <p>Morphological pressures / modifications: Heavily engineered in a trapezoidal channel with large earth embankments and rock reinforced toe. Floodplain controlled as flood storage areas with side-spill weirs/sluices. Series of rock ramps form grade control weirs which create small rapids</p> <p>Land use: Amenity grassland, urban/suburban, woodland</p>

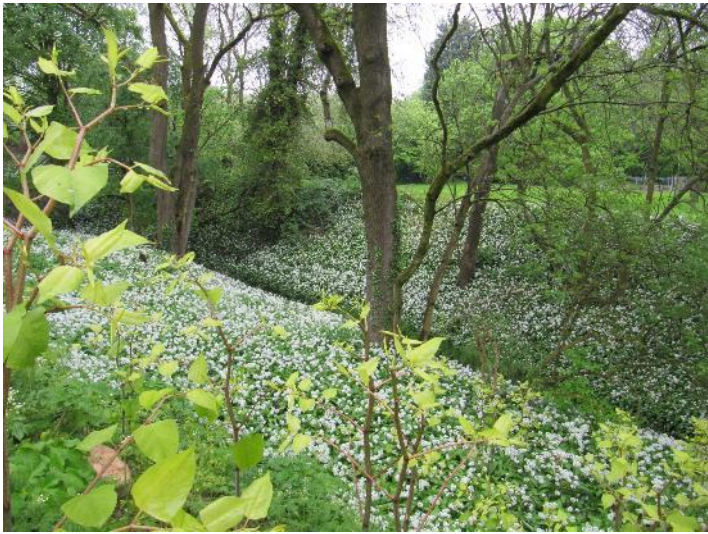
<p>Photograph taken from NGR SJ8344590959</p>

Table 107: Summary of baseline condition of Tributary of River Mersey 2 within the vicinity of the Proposed Scheme

Baseline description	Example photograph
<p>At location of Proposed Scheme Small watercourse deepened into a trapezoidal section discharging through embankment outfall structure into River Mersey</p>

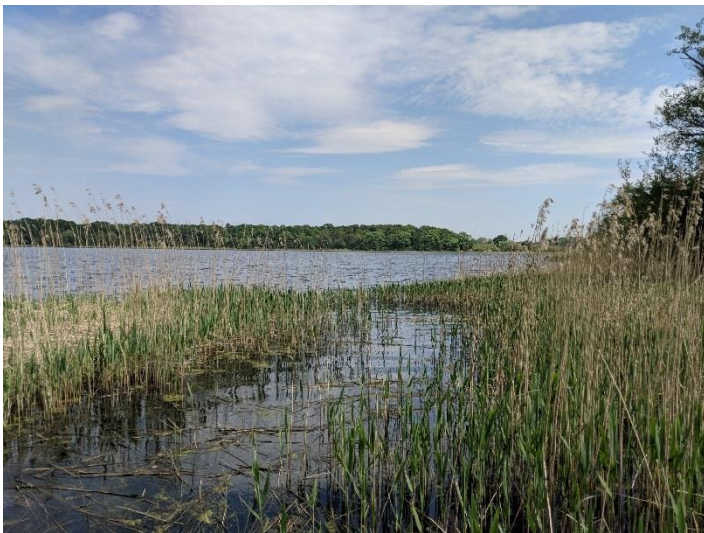
<p>Photograph taken from NGR SJ7430483802</p>

Table 112: Summary of baseline condition of Rostherne Mere

Description of feature	Example photograph
<p>Rostherne Mere has a surface area of approximately 48ha and a mean depth of 13.6m</p> <p>The Mere is fringed in places by a band of reedbed swamp</p> <p>There are also areas of willow carr⁸</p> <p>Rostherne Mere is supported by watercourses feeding in from the catchment. Rostherne Brook provides approximately 80% of the inflow into Rostherne Mere</p> <p>These streams are determined to be fed by spring, hence Rostherne Mere is at least partly a groundwater dependent habitat</p>
