High Speed Rail (Crewe – Manchester)

BID WR-002-00001_Part 2

Water Framework Directive compliance
assessment baseline data - Part 2 of 2

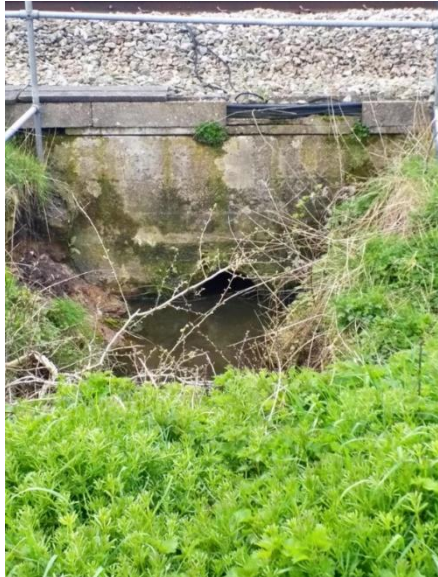
<p data-bbox="564 920 1054 943">Photograph taken from NGR SJ6873561830</p>

Description of feature	Example photograph
Piped discharge from beneath the railway – not a groundwater feature

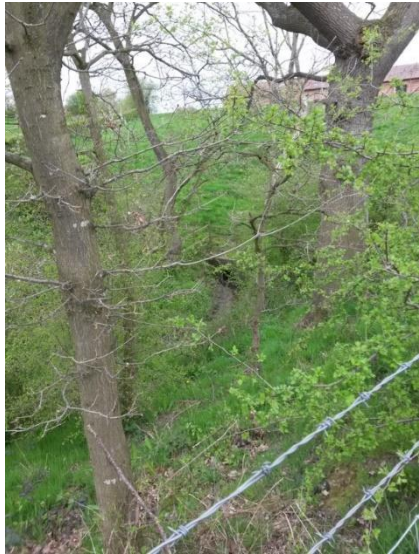
<p data-bbox="564 2040 1054 2063">Photograph taken from NGR SJ6807562288</p>

Description of feature	Example photograph
Culvert under the railway – not a groundwater feature

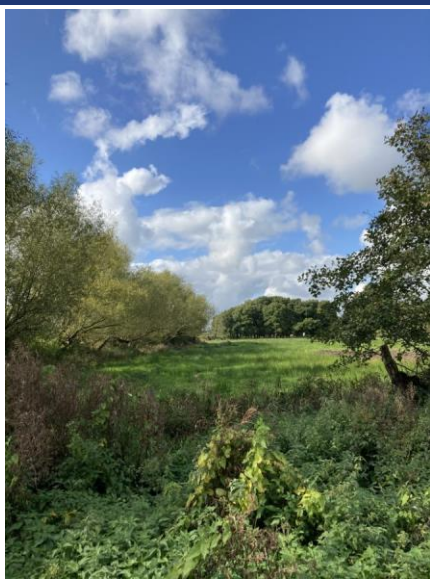
<p>Photograph taken from NGR SJ6962558759</p>

Description of feature	Example photograph
<p>Spring Plantation Grassland is a managed field with marshy grassland characteristics. Patches of reeds within field and crack willow in drainage ditch surrounding habitat were identified. Drainage ditch had stagnant water with signs of litter dumping. There may be a groundwater partially supporting the habitat from underlying glacial till. As such, the habitat is classified as a surface water and groundwater dependent habitat.</p>

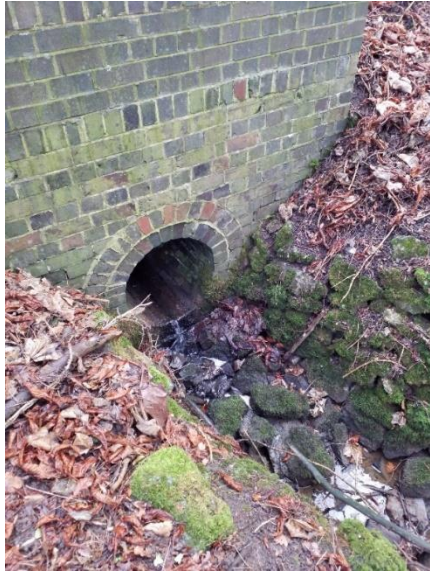
<p>Photograph taken from NGR SJ6780264427</p>

Description of feature	Example photograph
<p>Surveys were unable to identify a saliferous spring in the habitat. Access issues restricted further investigation. The saliferous spring is expected to be in the south of the SSSI habitat, where access was not available. A culvert was identified which drains underneath the Trent and Mersey Canal into Wimboldsley Wood. This is not assumed to be the saliferous spring.</p>

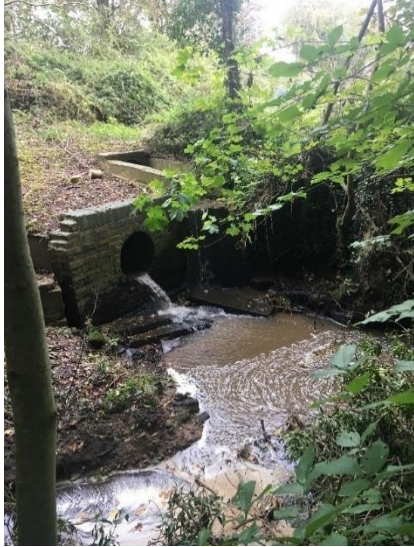
<p>Photograph taken from NGR SJ6894965735</p>

Description of feature	Example photograph
<p>Culvert passing Tributary of River Wheelock 5 under the Shropshire Union Canal, not a groundwater feature. Also, a second outfall adjacent to the culvert which is likely an overflow of the Shropshire Union Canal based on OS maps.</p> <p>The scum on water is originating from the discharge from potential spring S_27, which is in close proximity.</p>

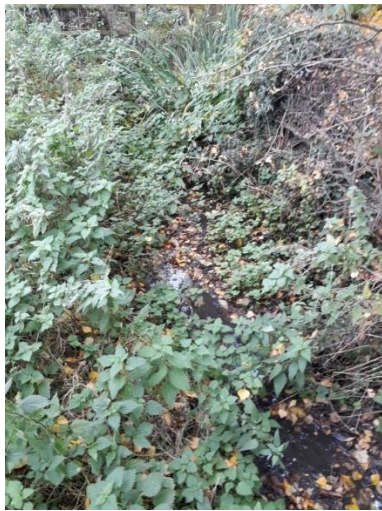
<p>Photograph taken from NGR SJ6890266690</p>

Description of feature	Example photograph
Surveys identified a spring flowing south-east. It is possible the spring is in hydraulic connection with the River Wheelock approximately 500m south-east of the spring. The water feature is located within a small, narrow ditch and likely receives input from drainage of surrounding fields. As such, the habitat at the spring is deemed partially groundwater dependent.

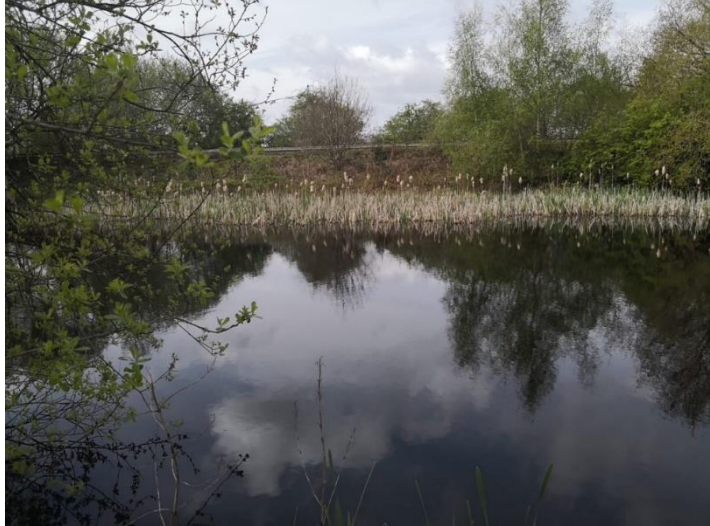
<p data-bbox="564 1868 1054 1897">Photograph taken from NGR SJ6865570455</p>

Description of feature	Example photograph
Water dependent habitats identified by surveys but were unable to determine if the habitat is fed by leakage from canal or groundwater.

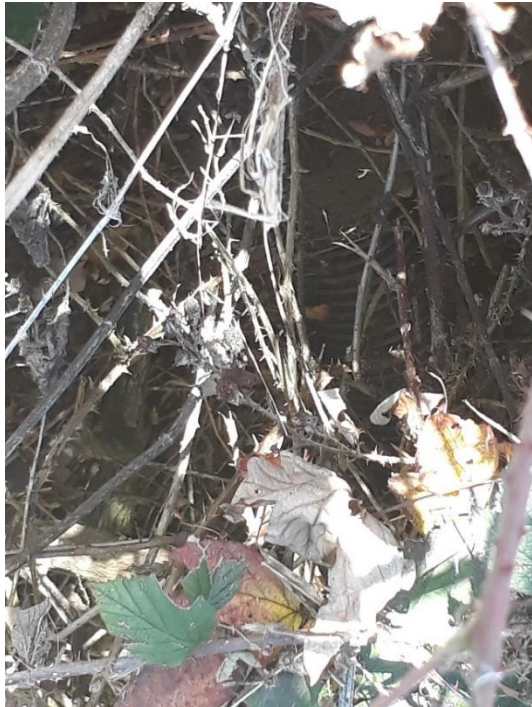
Photograph taken from NGR SJ7026775338

Description of feature	Example photograph
Drainage outfall and no groundwater dependent habitat in the vicinity – not a groundwater feature

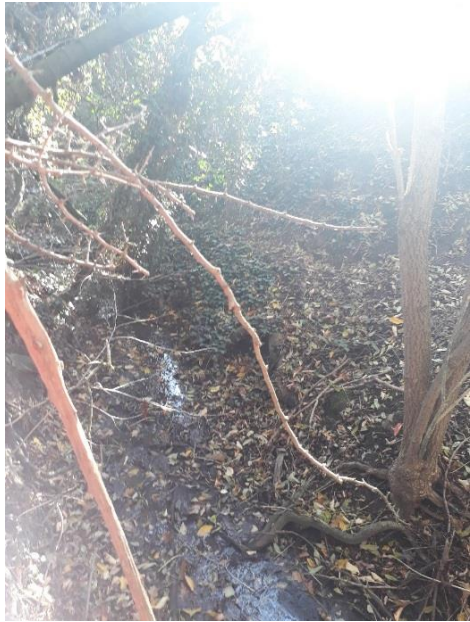
<p>Photograph taken from NGR SJ6972475960</p>

Description of feature	Example photograph
Unclear if drainage ditch or spring, thick mud and hydrogen sulphide smell. Channel likely receives drainage water from surface runoff from surrounding fields. Due to significant overland flow entering the area, it is unlikely to be impacted by the Proposed Scheme.

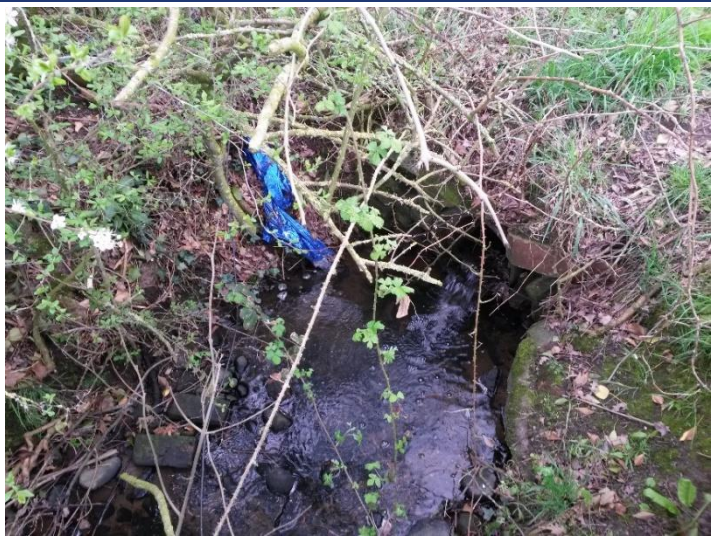
<p>Photograph taken from NGR SJ6974376547</p>

Description of feature	Example photograph
Culvert – not a groundwater feature

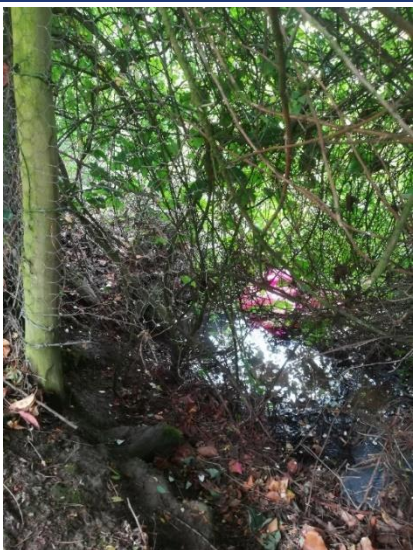
<p>Photograph taken from NGR SJ7145083461</p>

Description of feature	Example photograph
No obvious wetland habitat identified. The nature of the feature is uncertain due to access constraints and overgrown vegetation. The watercourse appears to start at roadside but not obvious if natural spring or culvert outfall as overgrown by hedge.

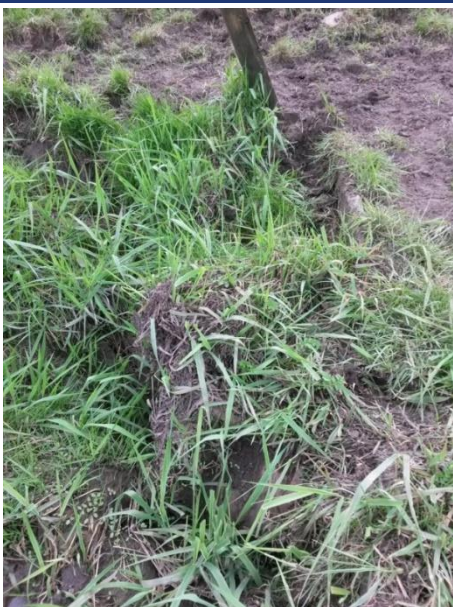
<p>Photograph taken from NGR SJ7196587528</p>

Description of feature	Example photograph
<p>Site visits have shown that this is not a groundwater feature. DRN indicates this is a culvert, not a groundwater feature.</p>

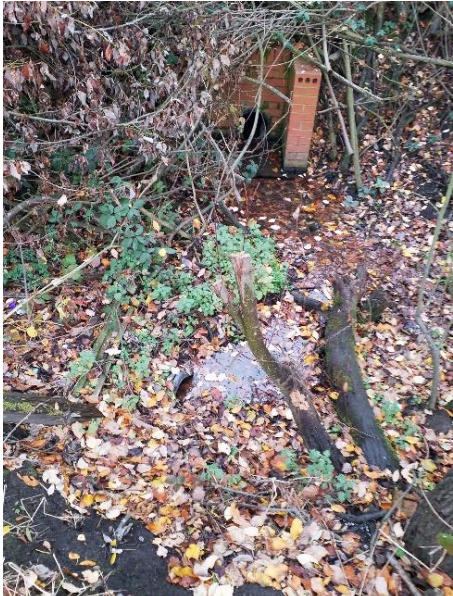
Description of feature	Example photograph
<p>Brick culvert drainage outfall. During survey, there was a strong smell of hydrogen sulphide, black staining of vegetation and white film deposit on water surface suggests possible pollution or misconnection to a sewer. This feature is not considered a groundwater feature.</p>

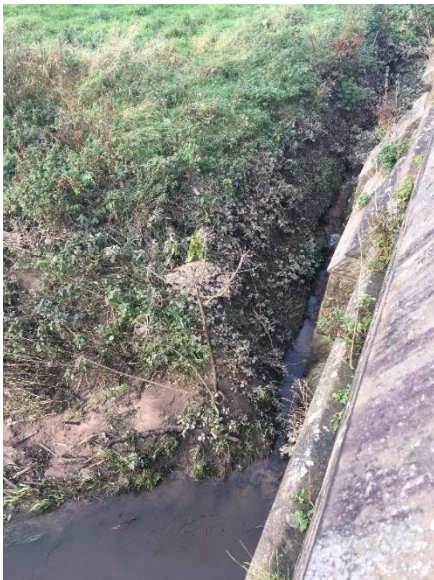
<p>Photograph taken from NGR SJ7023288773</p>

Description of feature	Example photograph
Drainage outfall with constructed brick opening flowing into the River Bollin. The outfall is contributing minimal flow compared to the flow of the River Bollin. Channel is constructed – it is a deep, manmade channel with bricks along the base alongside a bridge over the River Bollin. The watermark in the channel is much higher than current water level suggesting the flow changes seasonally, likely in response to rainfall. Also, likely some contribution from the road drainage network.

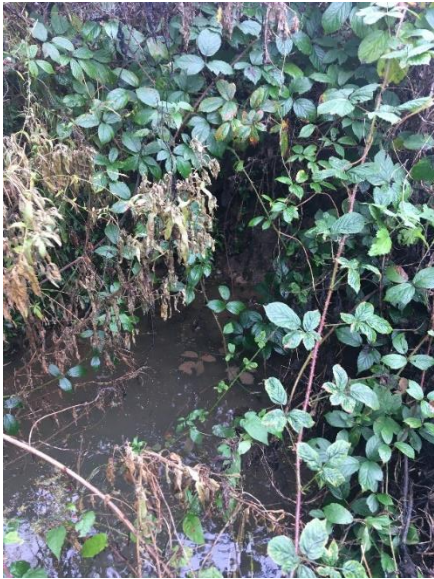
<p>Photograph taken from NGR SJ6823892314</p>

Description of feature	Example photograph
Culverted drainage outfall from underneath field with parked caravans. Possibly flowing from the farmhouse/outbuildings. OS maps show outfall discharges into Tributary of Glaze Brook 1.

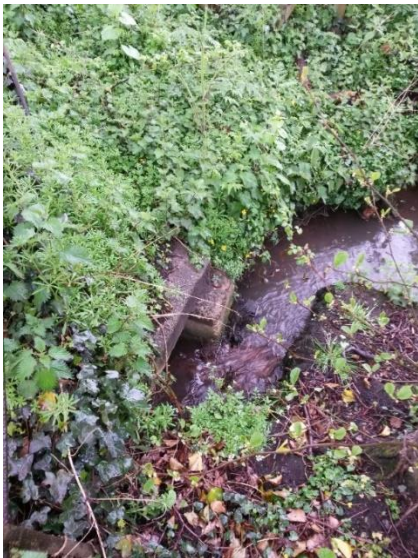
<p>Photograph taken from NGR SJ7675984039</p>

Description of feature	Example photograph
Land drainage outfall – not a groundwater feature

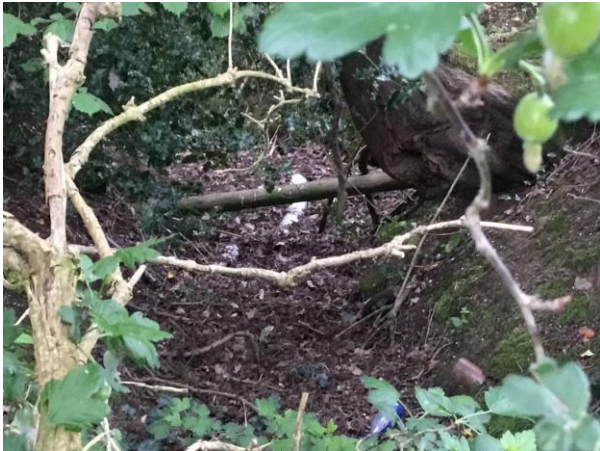
<p>Photograph taken from NGR SJ8043684044</p>

Description of feature	Example photograph
Land drainage channel – not a groundwater feature

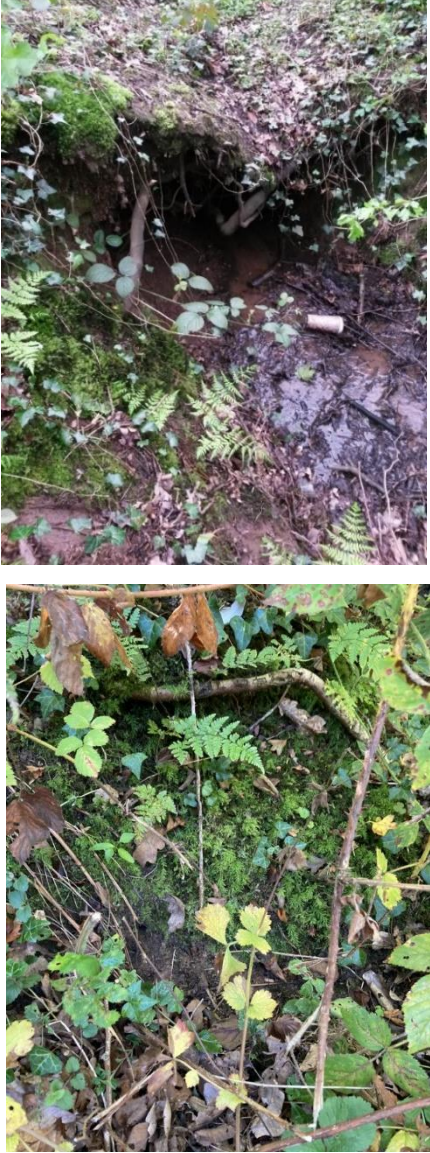
Photograph taken from NGR SJ7955084161

Description of feature	Example photograph
<p>Surveys identified wetland ecology (mosses and Yorkshire fog) at site with a dry channel downslope of the spring. No flow identified from spring at time of survey hence this is likely a seasonal spring. Spring was also identified during a different survey.</p> <p>Buried pipe was also located which may be connected to land drainage system.</p>

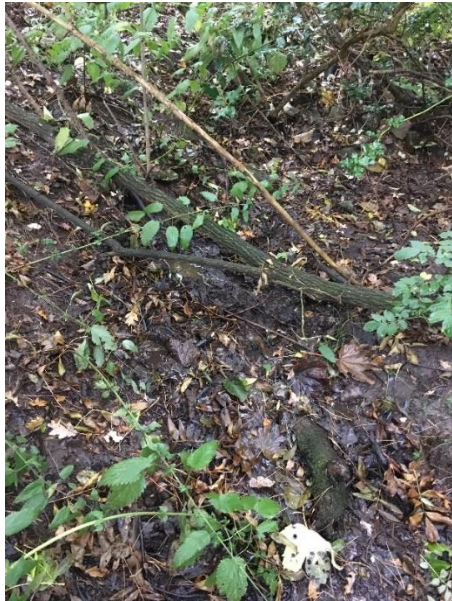
<p data-bbox="564 2013 1054 2042">Photograph taken from NGR SJ7905584438</p>

Description of feature	Example photograph
<p>A spring was located during field survey of potential spring S_144a. There is a brick and slab near the spring however, this has collapsed and been infilled with sediment. When soil was dug away, water seeped out slowly. Natural channel downstream of spring differs from the dug-out channels of the land drains and a few ferns were located around the spring.</p>

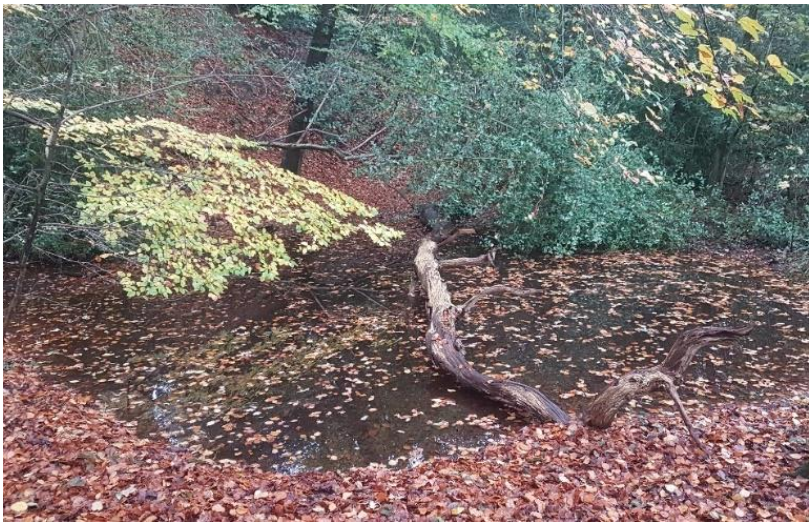
<p>Photograph taken from NGR SJ7926084652</p>

Description of feature	Example photograph
<p>Habitat is not considered to be groundwater dependent. Several ponds observed within the habitat at base of valley sides at the break in slopes. No evidence these ponds are groundwater collects but likely instead originate from overland flow down valley sides, and the ponds had little marginal habitat. Culverted ditches within the habitat.</p> <p>Some evidence of groundwater flow into the River Bollin so likely groundwater is at depth; no evidence of groundwater geomorphology or dependency away from the River Bollin.</p>

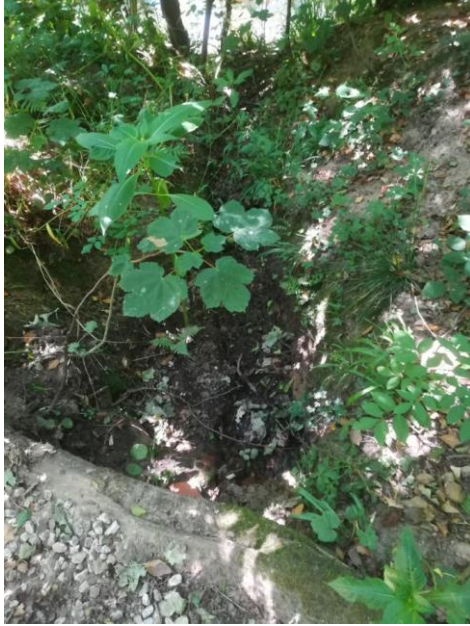
<p data-bbox="564 972 1051 1001">Photograph taken from NGR SJ7920584687</p>

Description of feature	Example photograph
Surveys could not find any evidence of a sink (as shown on OS maps) at the site. The only feature located was a culvert.

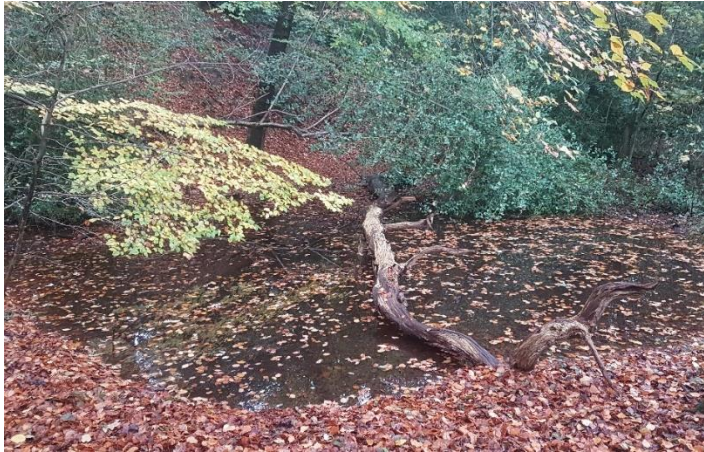
<p>Photograph taken from NGR SJ7908484743</p>

Description of feature	Example photograph
<p>Several ponds observed within the habitat at break in slopes. No evidence that these ponds are groundwater collects but likely instead originate from overland flow down valley sides. The ponds had little marginal habitat. Culverted ditches identified within the habitat.</p> <p>Some evidence of groundwater flow into the River Bollin so likely groundwater flow at depth. The spring 90m west of Halesmere Avenue, Hale, located at the northern edge of the habitat, flows through the habitat into the River Bollin. However, there is little evidence of groundwater geomorphology or dependency away from the River Bollin.</p> <p>Habitat is deemed surface water and groundwater dependent although is scoped out due to the lack of impact pathway for hydrological impact.</p>

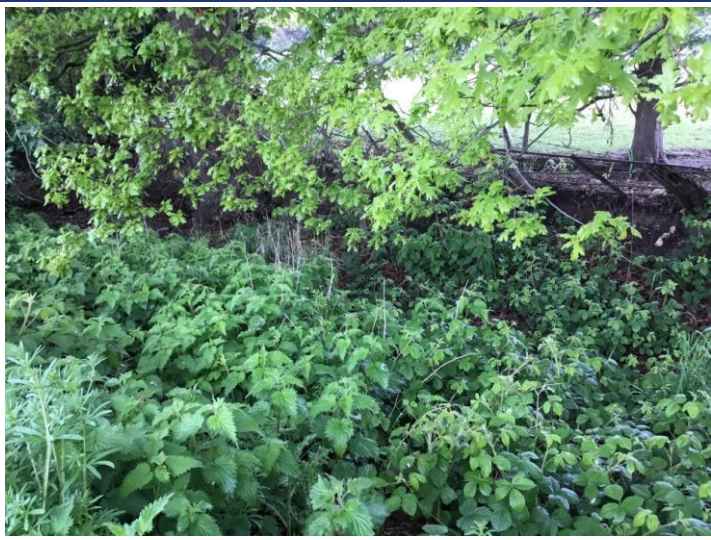
<p>Photograph taken from NGR SJ7326185393</p>

Description of feature	Example photograph
This is a land drainage feature with no evidence of wetland habitat or groundwater dependency at the feature. The ditch was dry during the field survey however likely supports overland flow during high precipitation events. Not a groundwater feature.

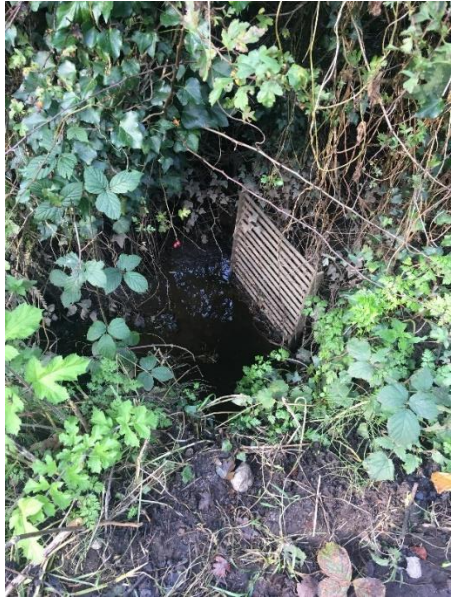
<p data-bbox="564 1339 1018 1357">Photograph taken from NGR SJ7339985553</p>

Description of feature	Example photograph
Manmade drain with metal grid with a square brick hole at bottom of drain. Connected to dug out drain alongside road. Ditch is culverted under driveways further upstream. Likely connected to local drainage network. Road drain adjacent to the potential sink.

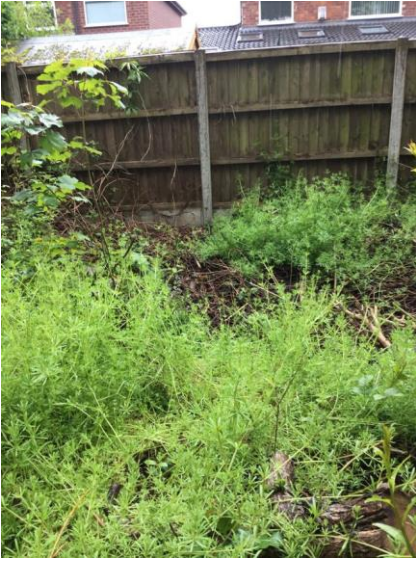
<p>Photograph taken from NGR SJ8180988919</p>

Description of feature	Example photograph
<p>Surveys unable to identify a feature during the field survey. The feature is connected to a culvert under a railway. Assumed to be a High value receptor until confirmed by further field surveys.</p>

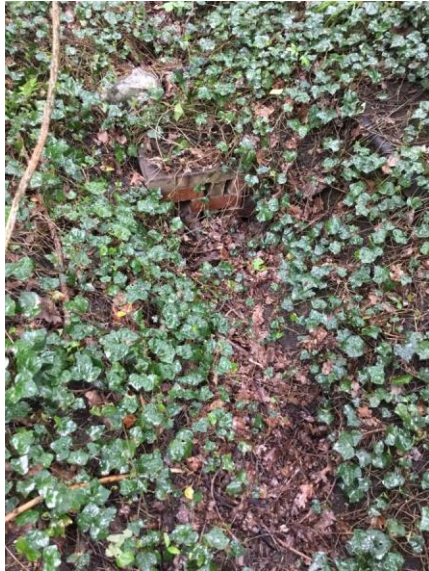
<p>Photograph taken from NGR SJ8248589335</p>

Description of feature	Example photograph
Culvert – not a groundwater feature

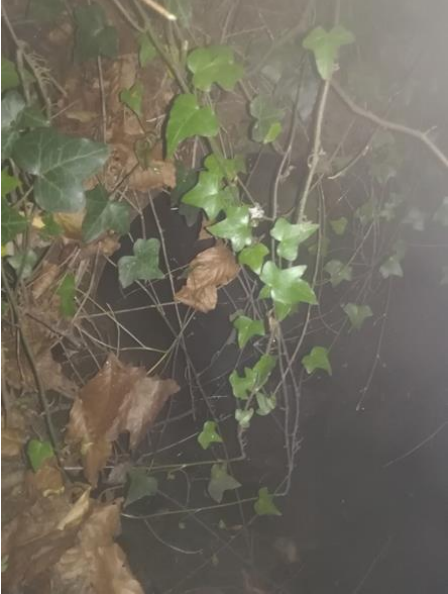
<p data-bbox="568 1153 1054 1171">Photograph taken from NGR SJ7126486223</p>

Description of feature	Example photograph
Culvert – not a groundwater feature

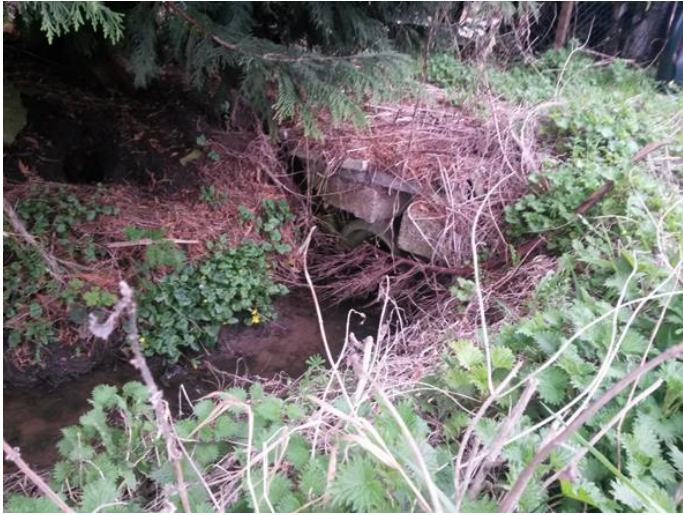
<p>Photograph taken from NGR SJ7137186394</p>

Description of feature	Example photograph
Culvert – not a groundwater feature

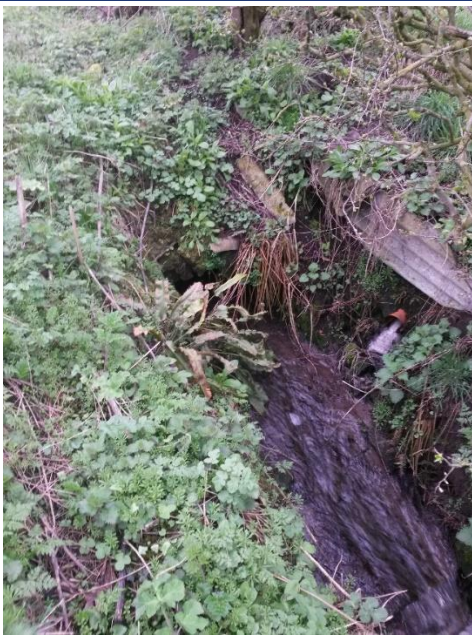
<p>Photograph taken from NGR SJ7141886465</p>

Description of feature	Example photograph
Culvert – not a groundwater feature

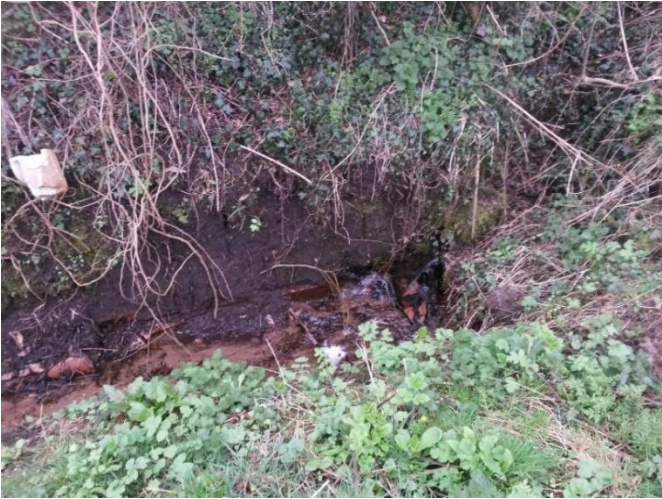
<p data-bbox="568 842 1054 866">Photograph taken from NGR SJ7146286534</p>

Description of feature	Example photograph
Culvert/drainage outfall – not a groundwater feature

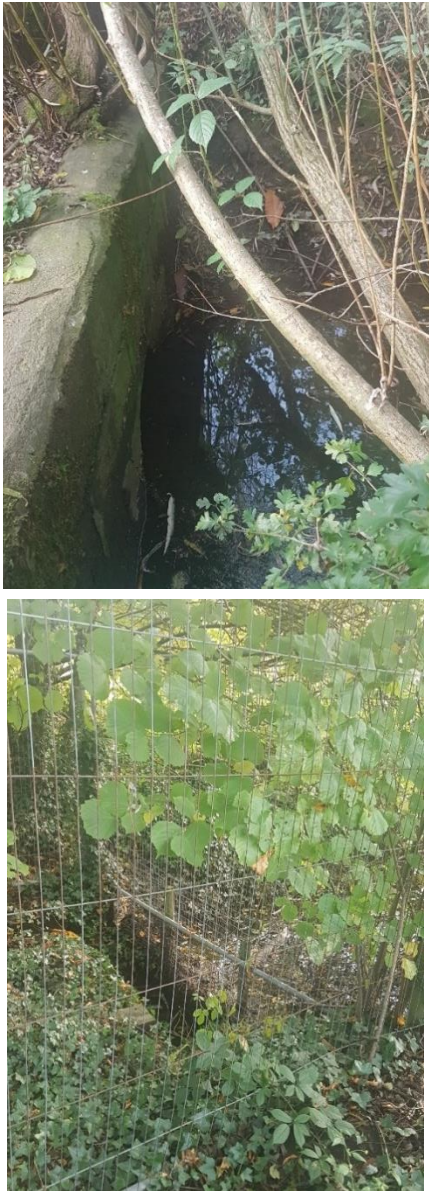
<p>Photographs taken from NGR SJ7037987302</p>

Description of feature	Example photographs
<p>Large culvert passing under footpath. Stagnant water observed downstream as the watercourse flows through a fence ~10m downstream which is causing build-up of debris on water surface. Water then flows into a large, constructed drain to pass under the road or Bridgewater Canal. OS maps show the watercourse is Helsdale Brook.</p>

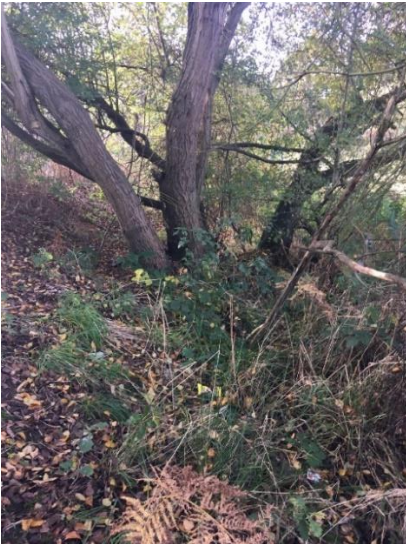
<p>Photograph taken from NGR SJ6992692665</p>

Description of feature	Example photograph
<p>Managed farmland upgradient of potential spring. Potential to classify this feature as a groundwater collect which is slowly draining into Glaze Brook as there is an area of closed depression with groundwater dependent habitat.</p>

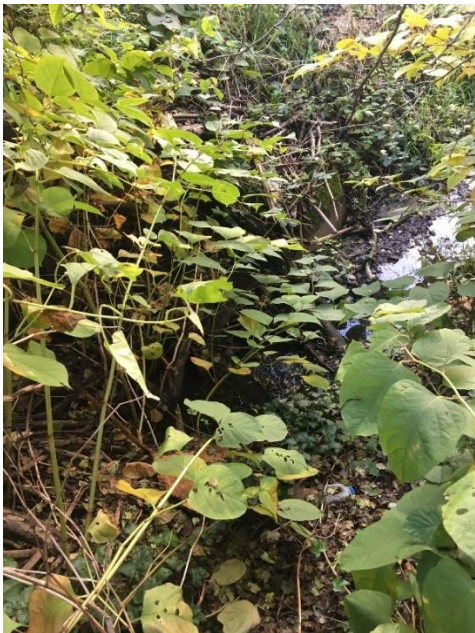
<p>Photograph taken from NGR SD6085100815</p>

Description of feature	Example photograph
Culvert passing under Crankwood Road – not a groundwater feature
